The Nutrient Content of Stream Sediments

**CENTER FOR
WATERSHED
PROTECTION**

**The Peculiarities of
Perviousness**

Feb. 12-13, 2014

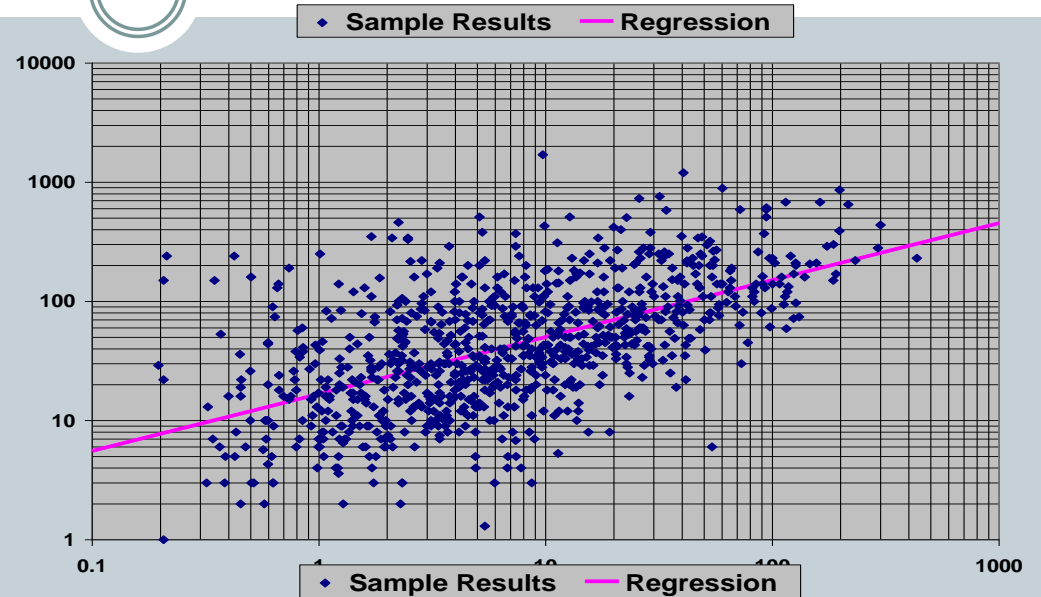
Typical flow vs. TSS

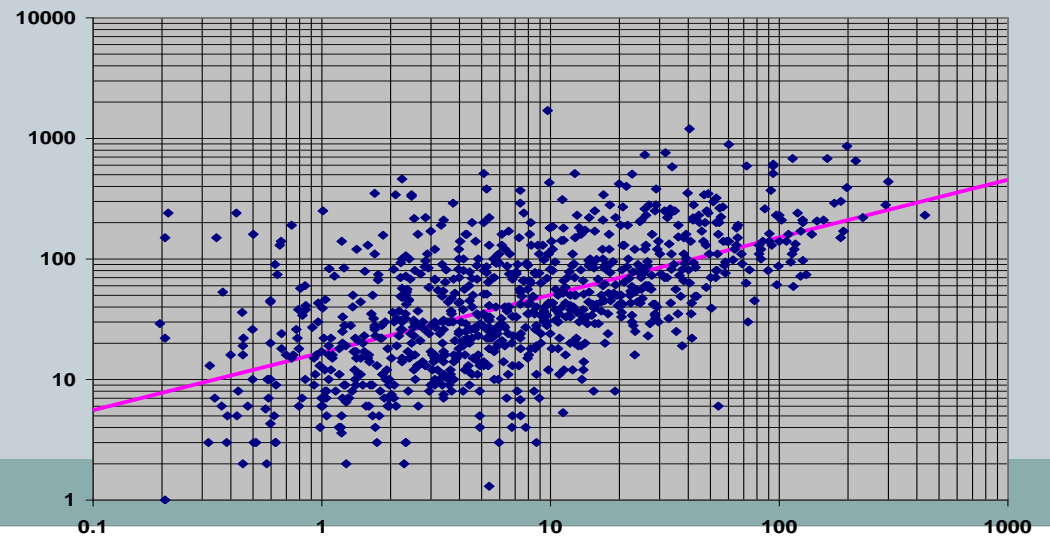
Typical flow vs. TP

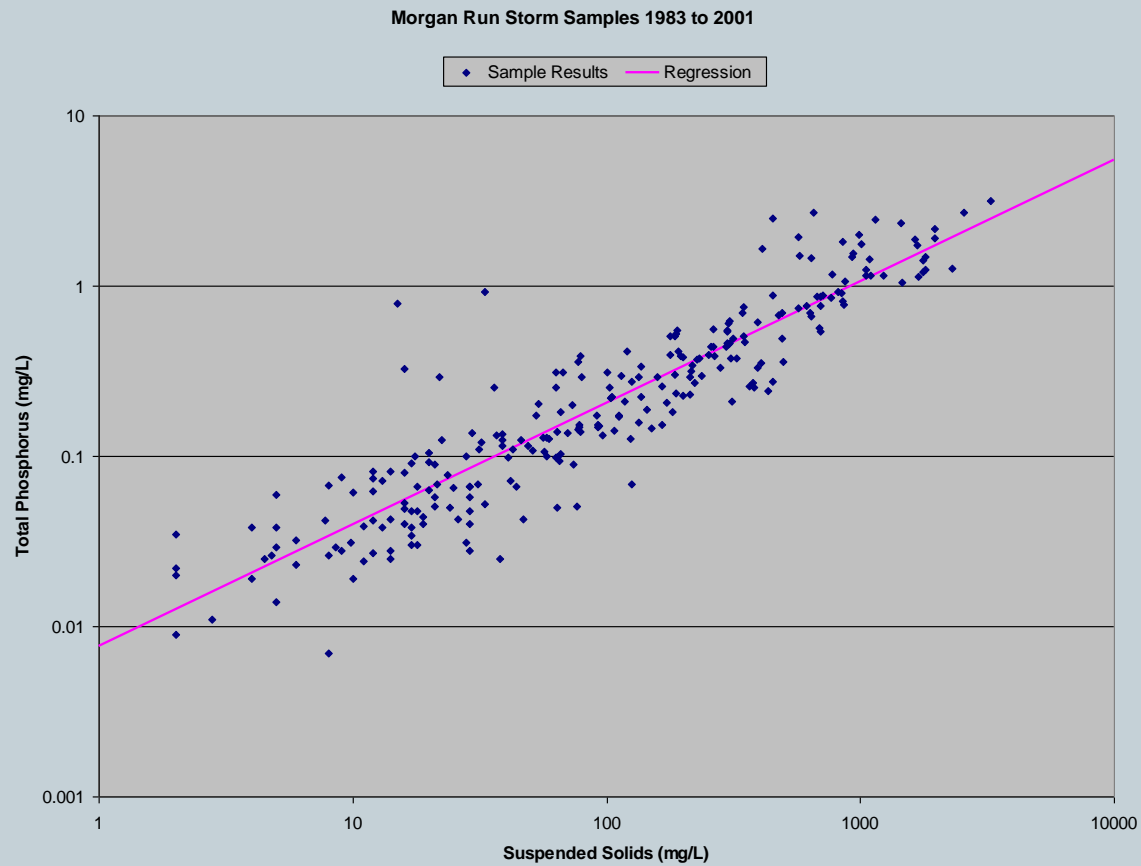
Typical TSS vs. TP relationship

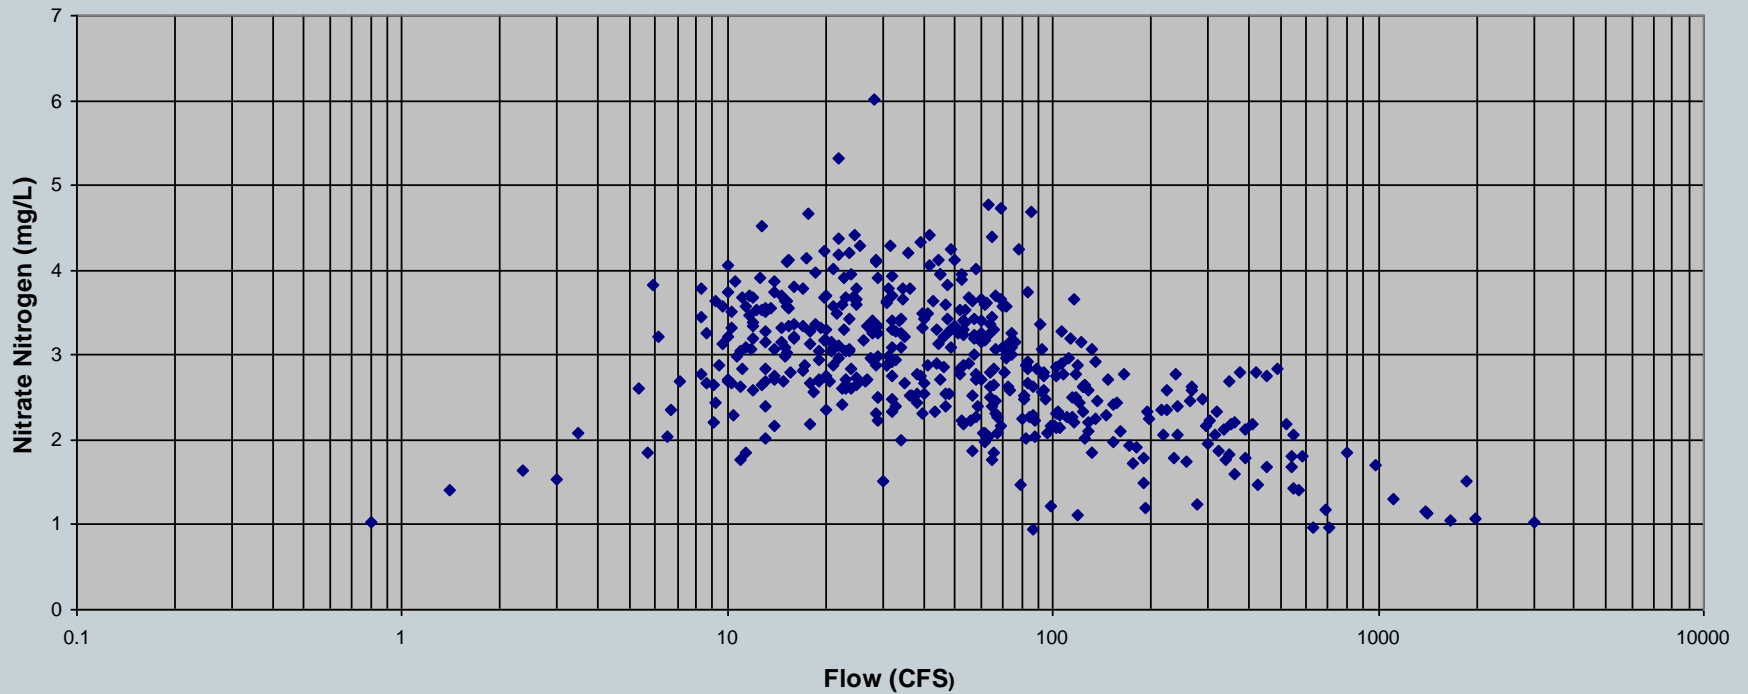
Typical Nitrate vs. Flow

Morgan Run (MOR0040) Storm & Baseline Samples 1982-2005

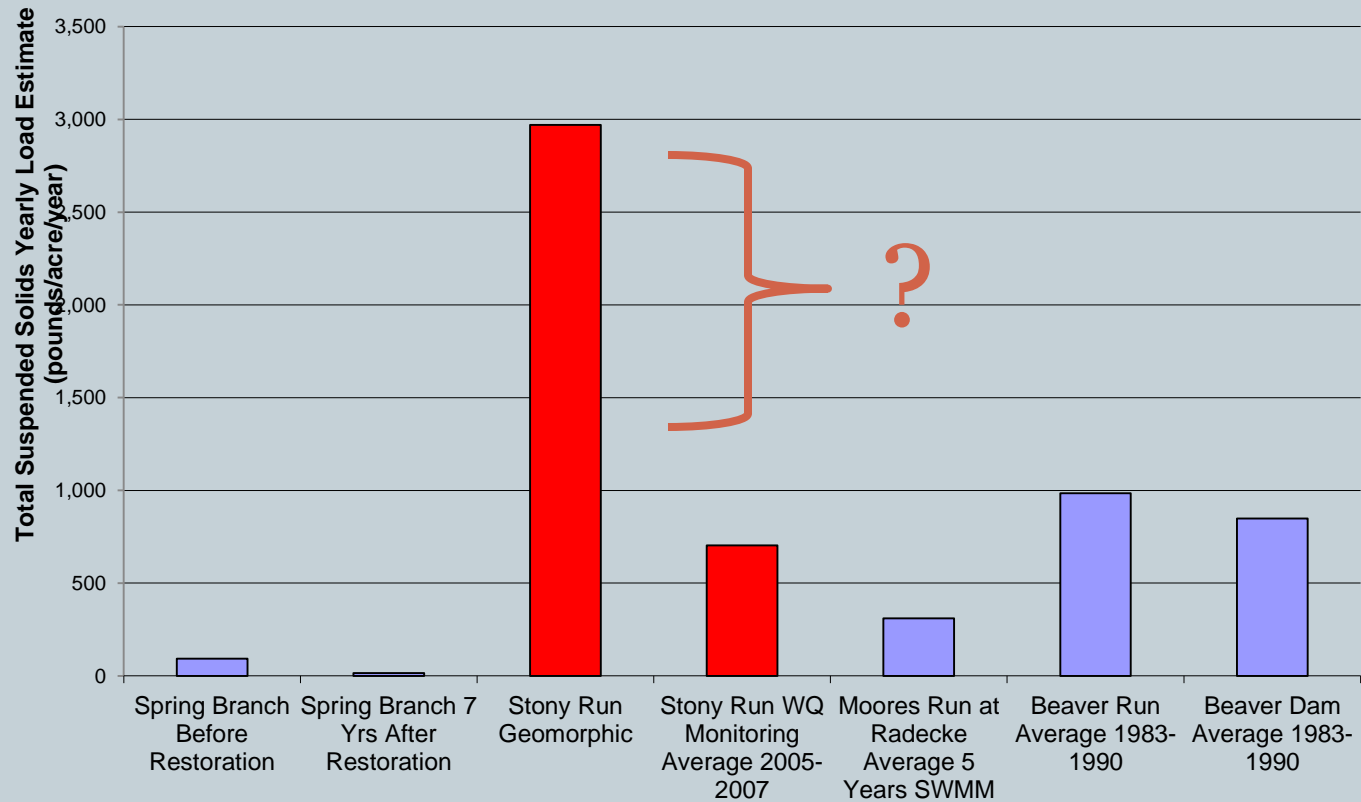
Compare Total Suspended Solids Load Estimates by different methods and lancovers
