Questions for the Panel:

- How should legacy sediment be defined in the context of Chesapeake Bay management?
- **What is the importance of legacy sediments compared to other sediment sources?**
- To what extent do legacy sediments provide an important source of nutrient contributions in comparison with other sources?

Prepared by D. Merritts, R. Walter, and M. Rahnis, based on collaborations with many partners.

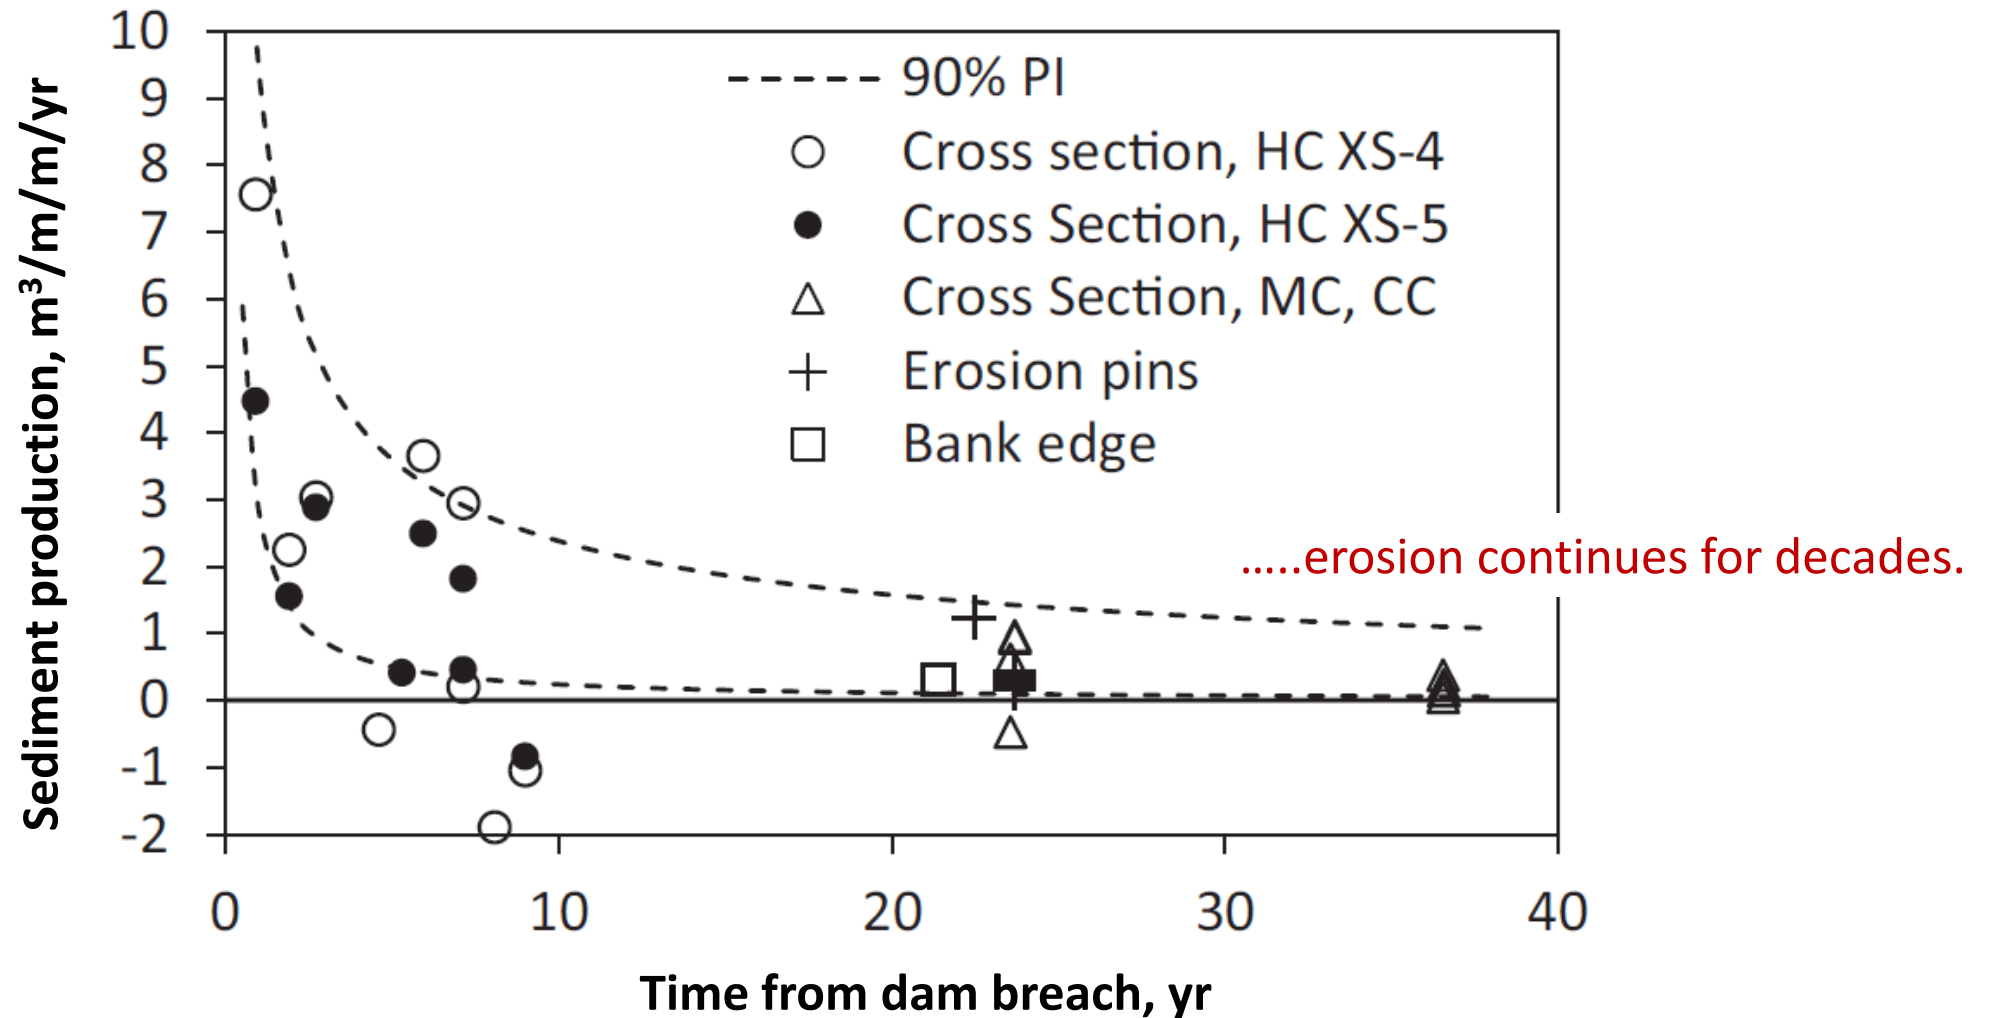
Bank erosion rates greatest after dam breaching

Measured by repeat surveying and erosion pins; Merritts et al, 2013 (PA sites)

Negative power function fit to positive data (n = 26).

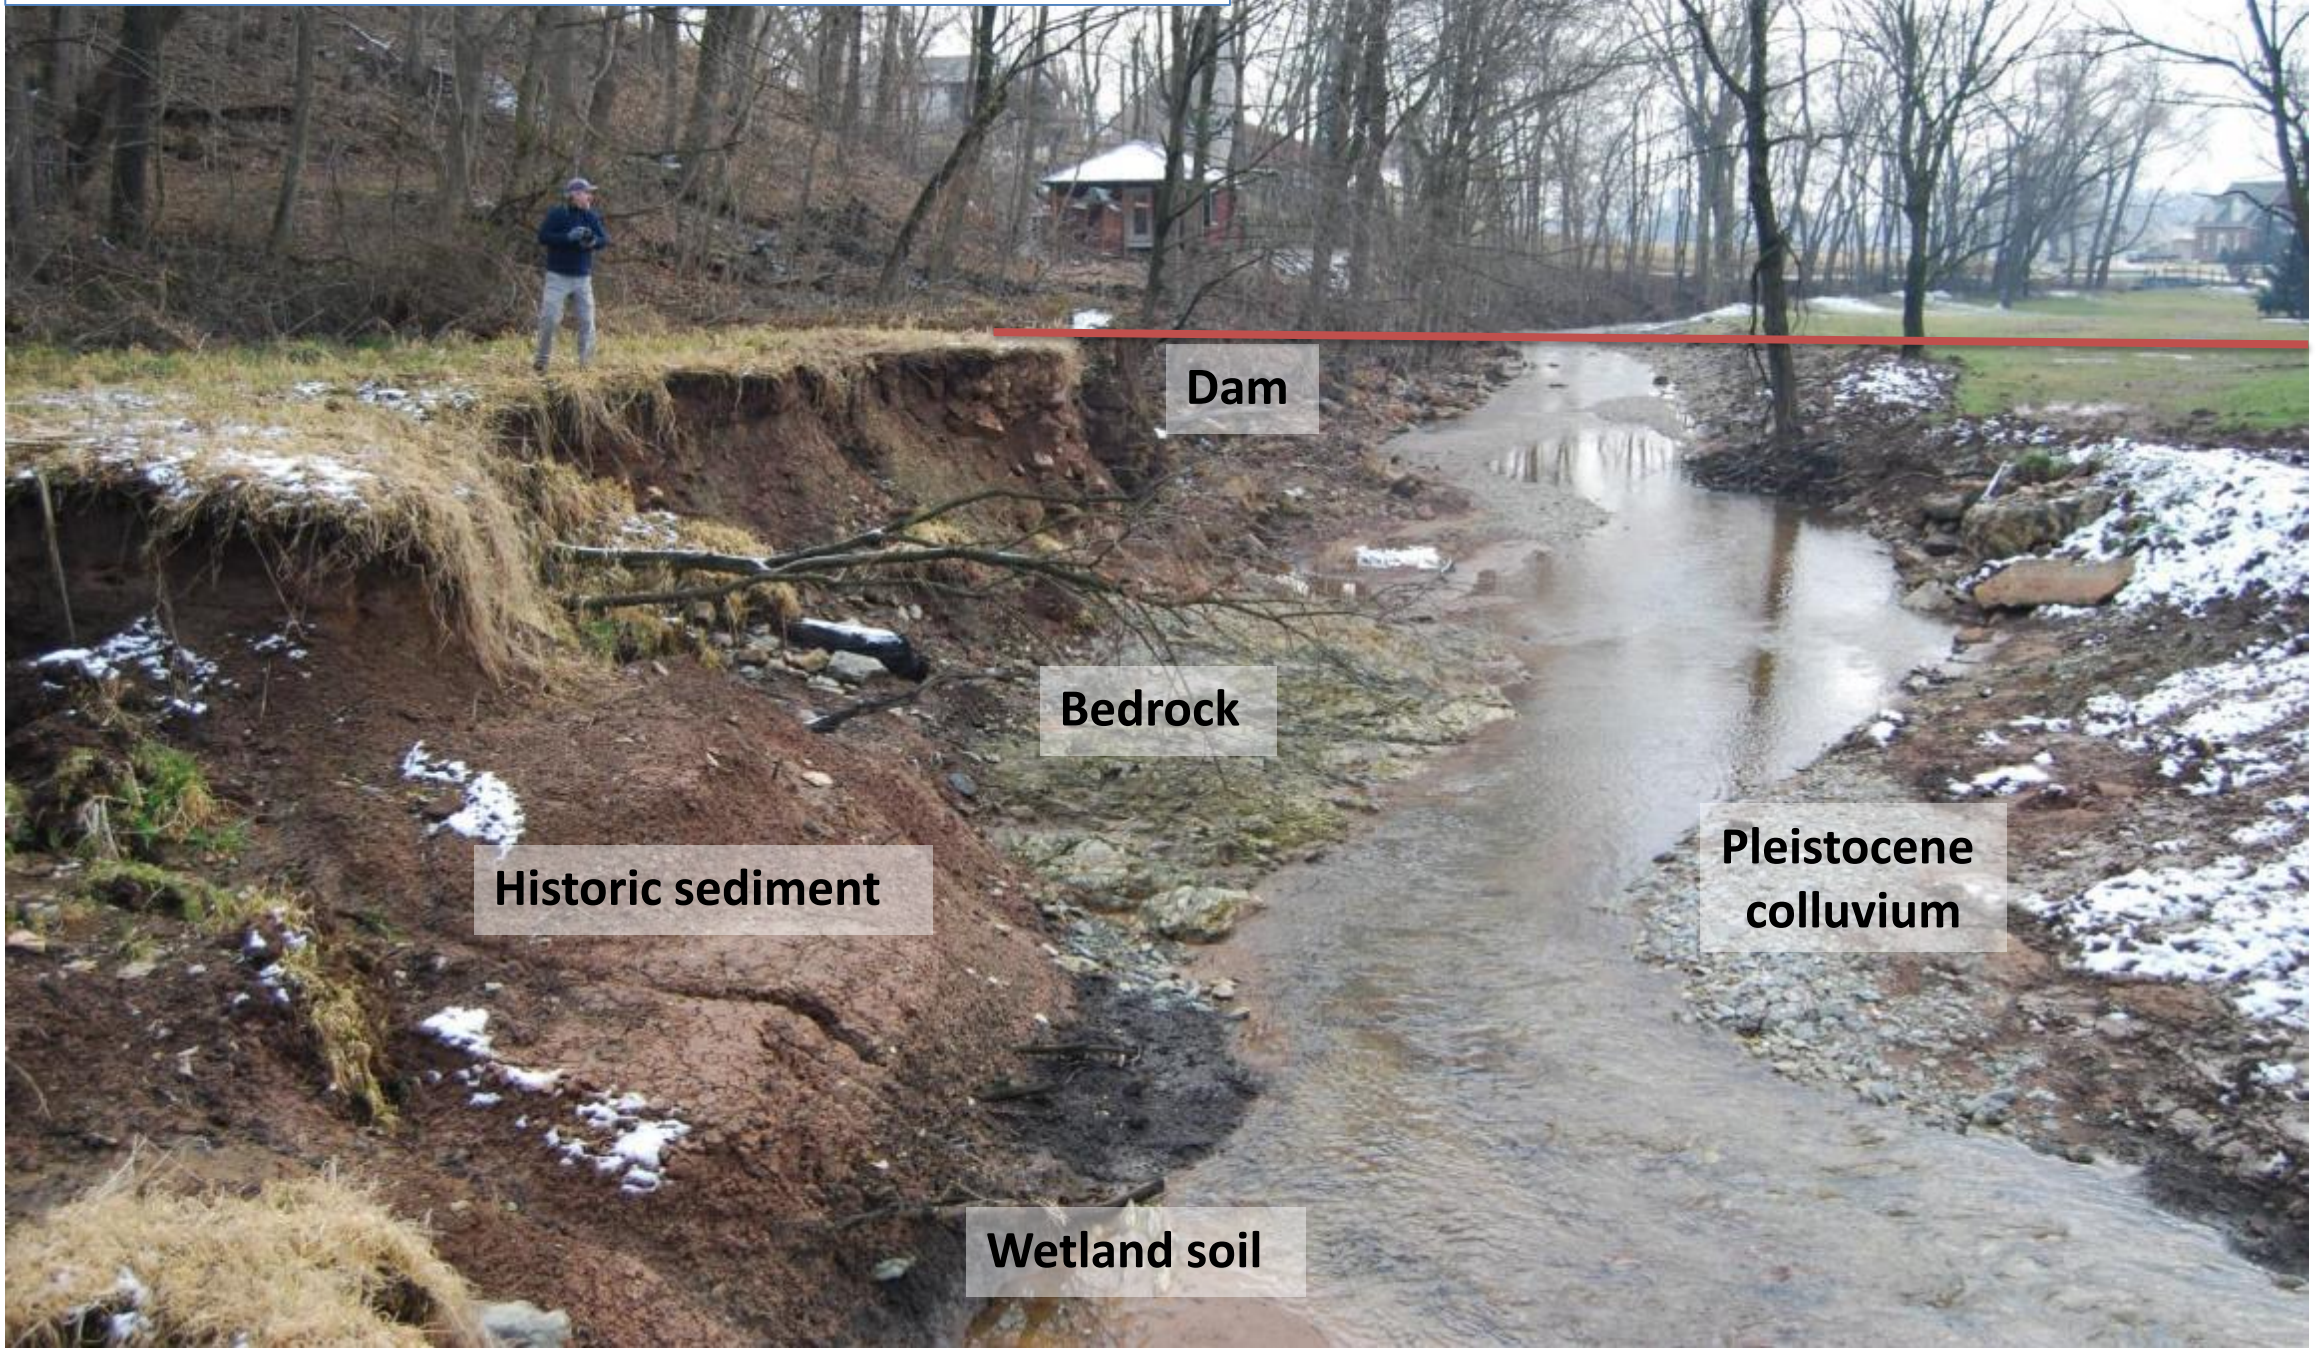
Indian Run, PA – Stobers Dam breach, 2011

Dam

Bedrock

Historic sediment

Pleistocene colluvium

Wetland soil

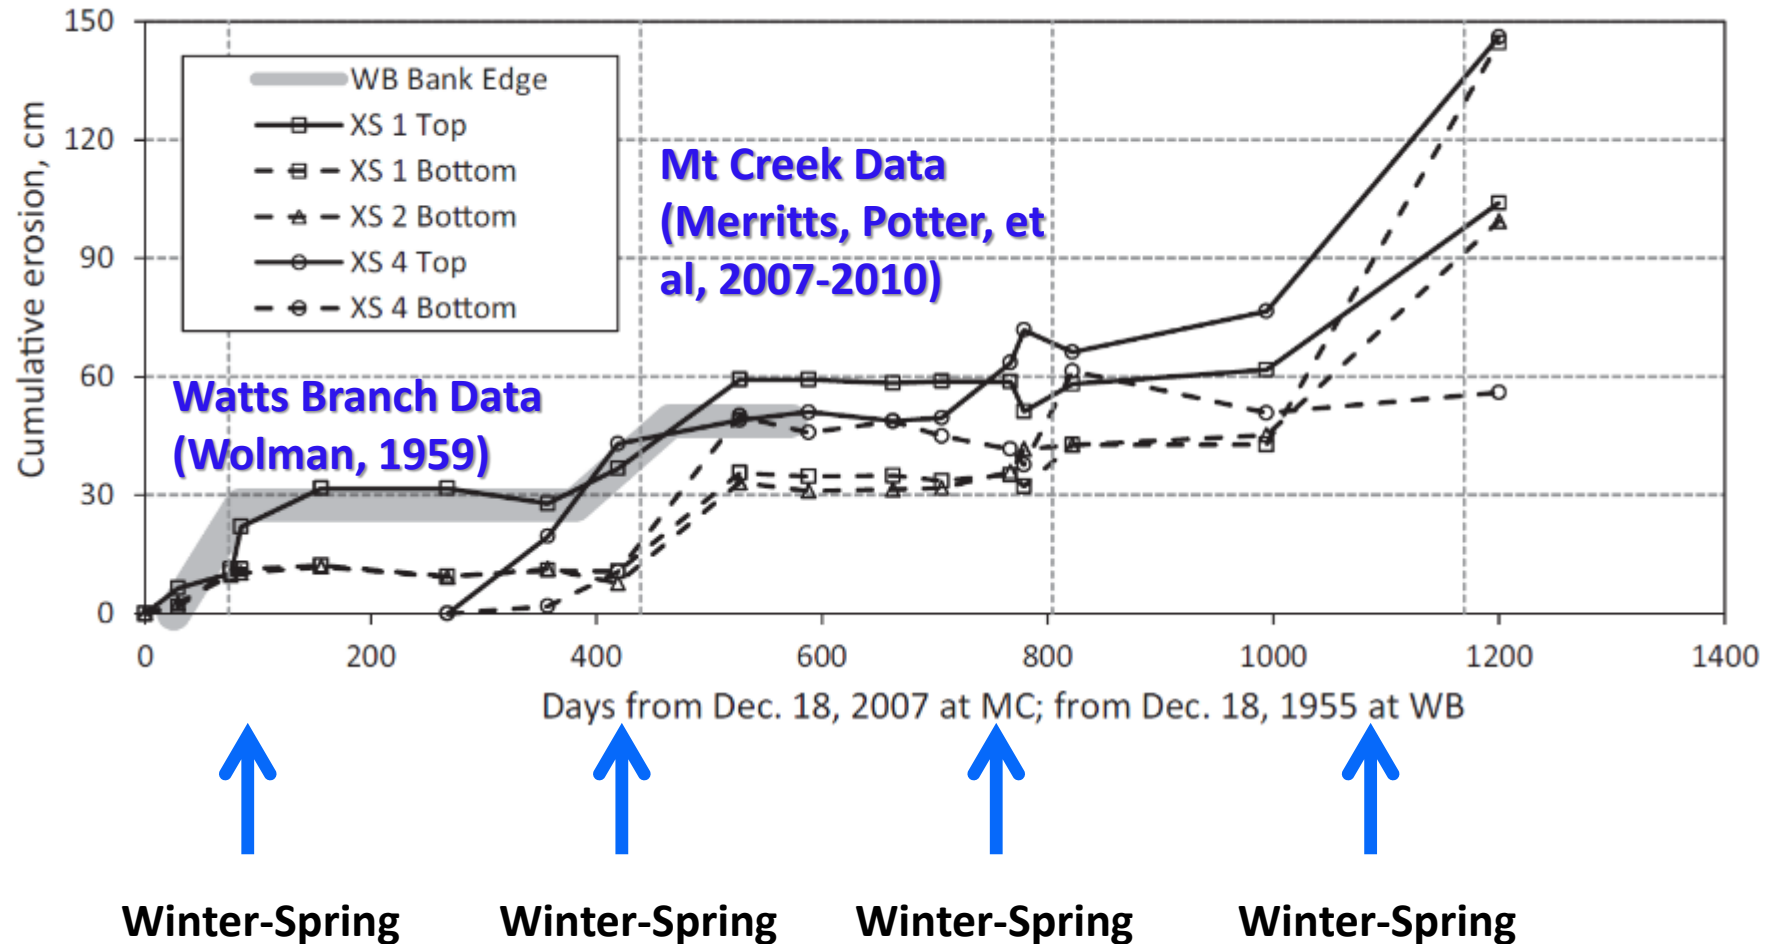
Freeze-thaw Drives Bank Retreat During December-March

Data collected by Merritts, Potter, Jenschke, et al. See Merritts et al. in GSA Eng. Geo, 2013. See Wolman, 1959, Factors influencing erosion of a cohesive river bank (Amer. Jnl of Science). Also works by Lawler, Wynn, et al.

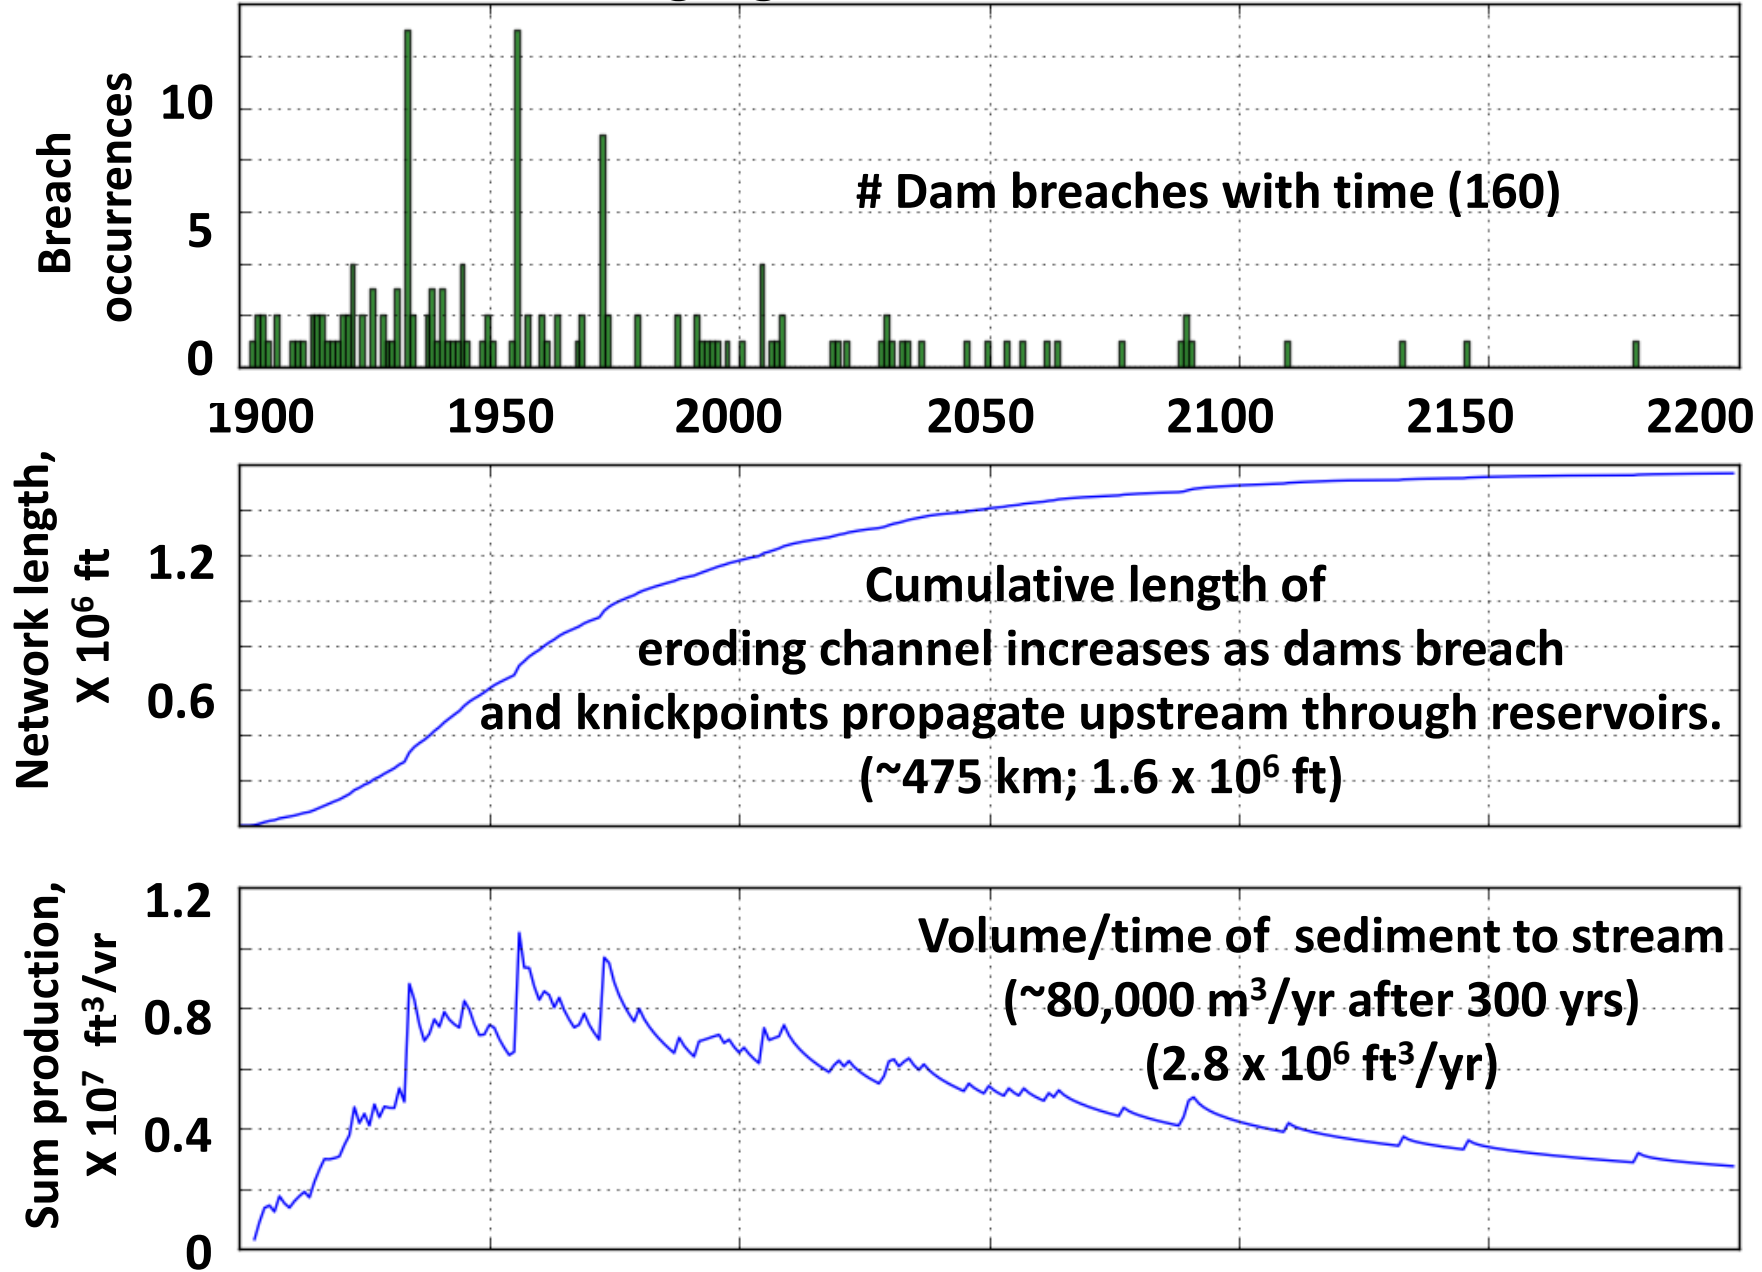
Simulating 300 yrs Post-breach sediment loading to streams

Modeling lag times in sediment fluxes

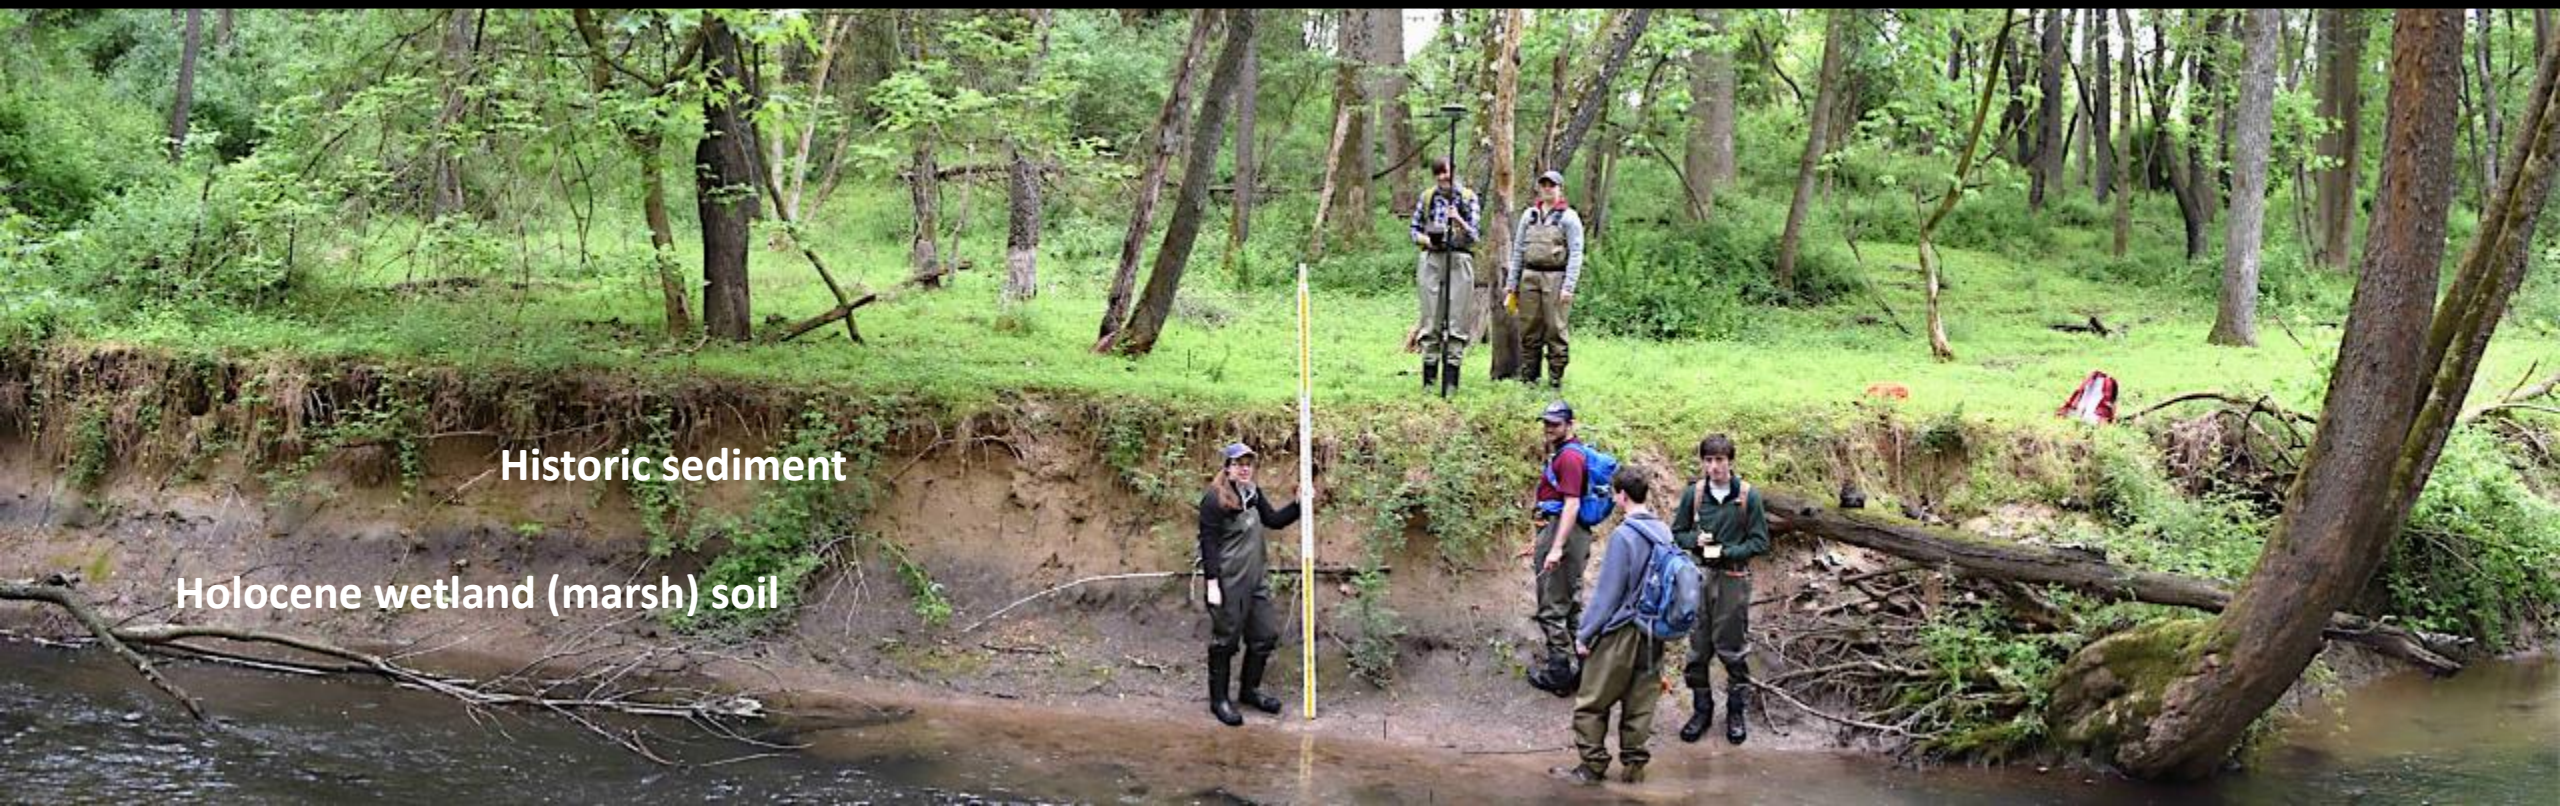
Along Piney Run, MD, from Browns Mill (Slacks Rd) to De Vries Mill (Arrington Rd)

Piney Run--"Pompeii effect"--Historic sediment buries pre-settlement landscape, draped over pre-existing topography

Brown: <300 yrs BP
Historic sediment

Black: Holocene
wet meadow
300-11,200 yrs BP

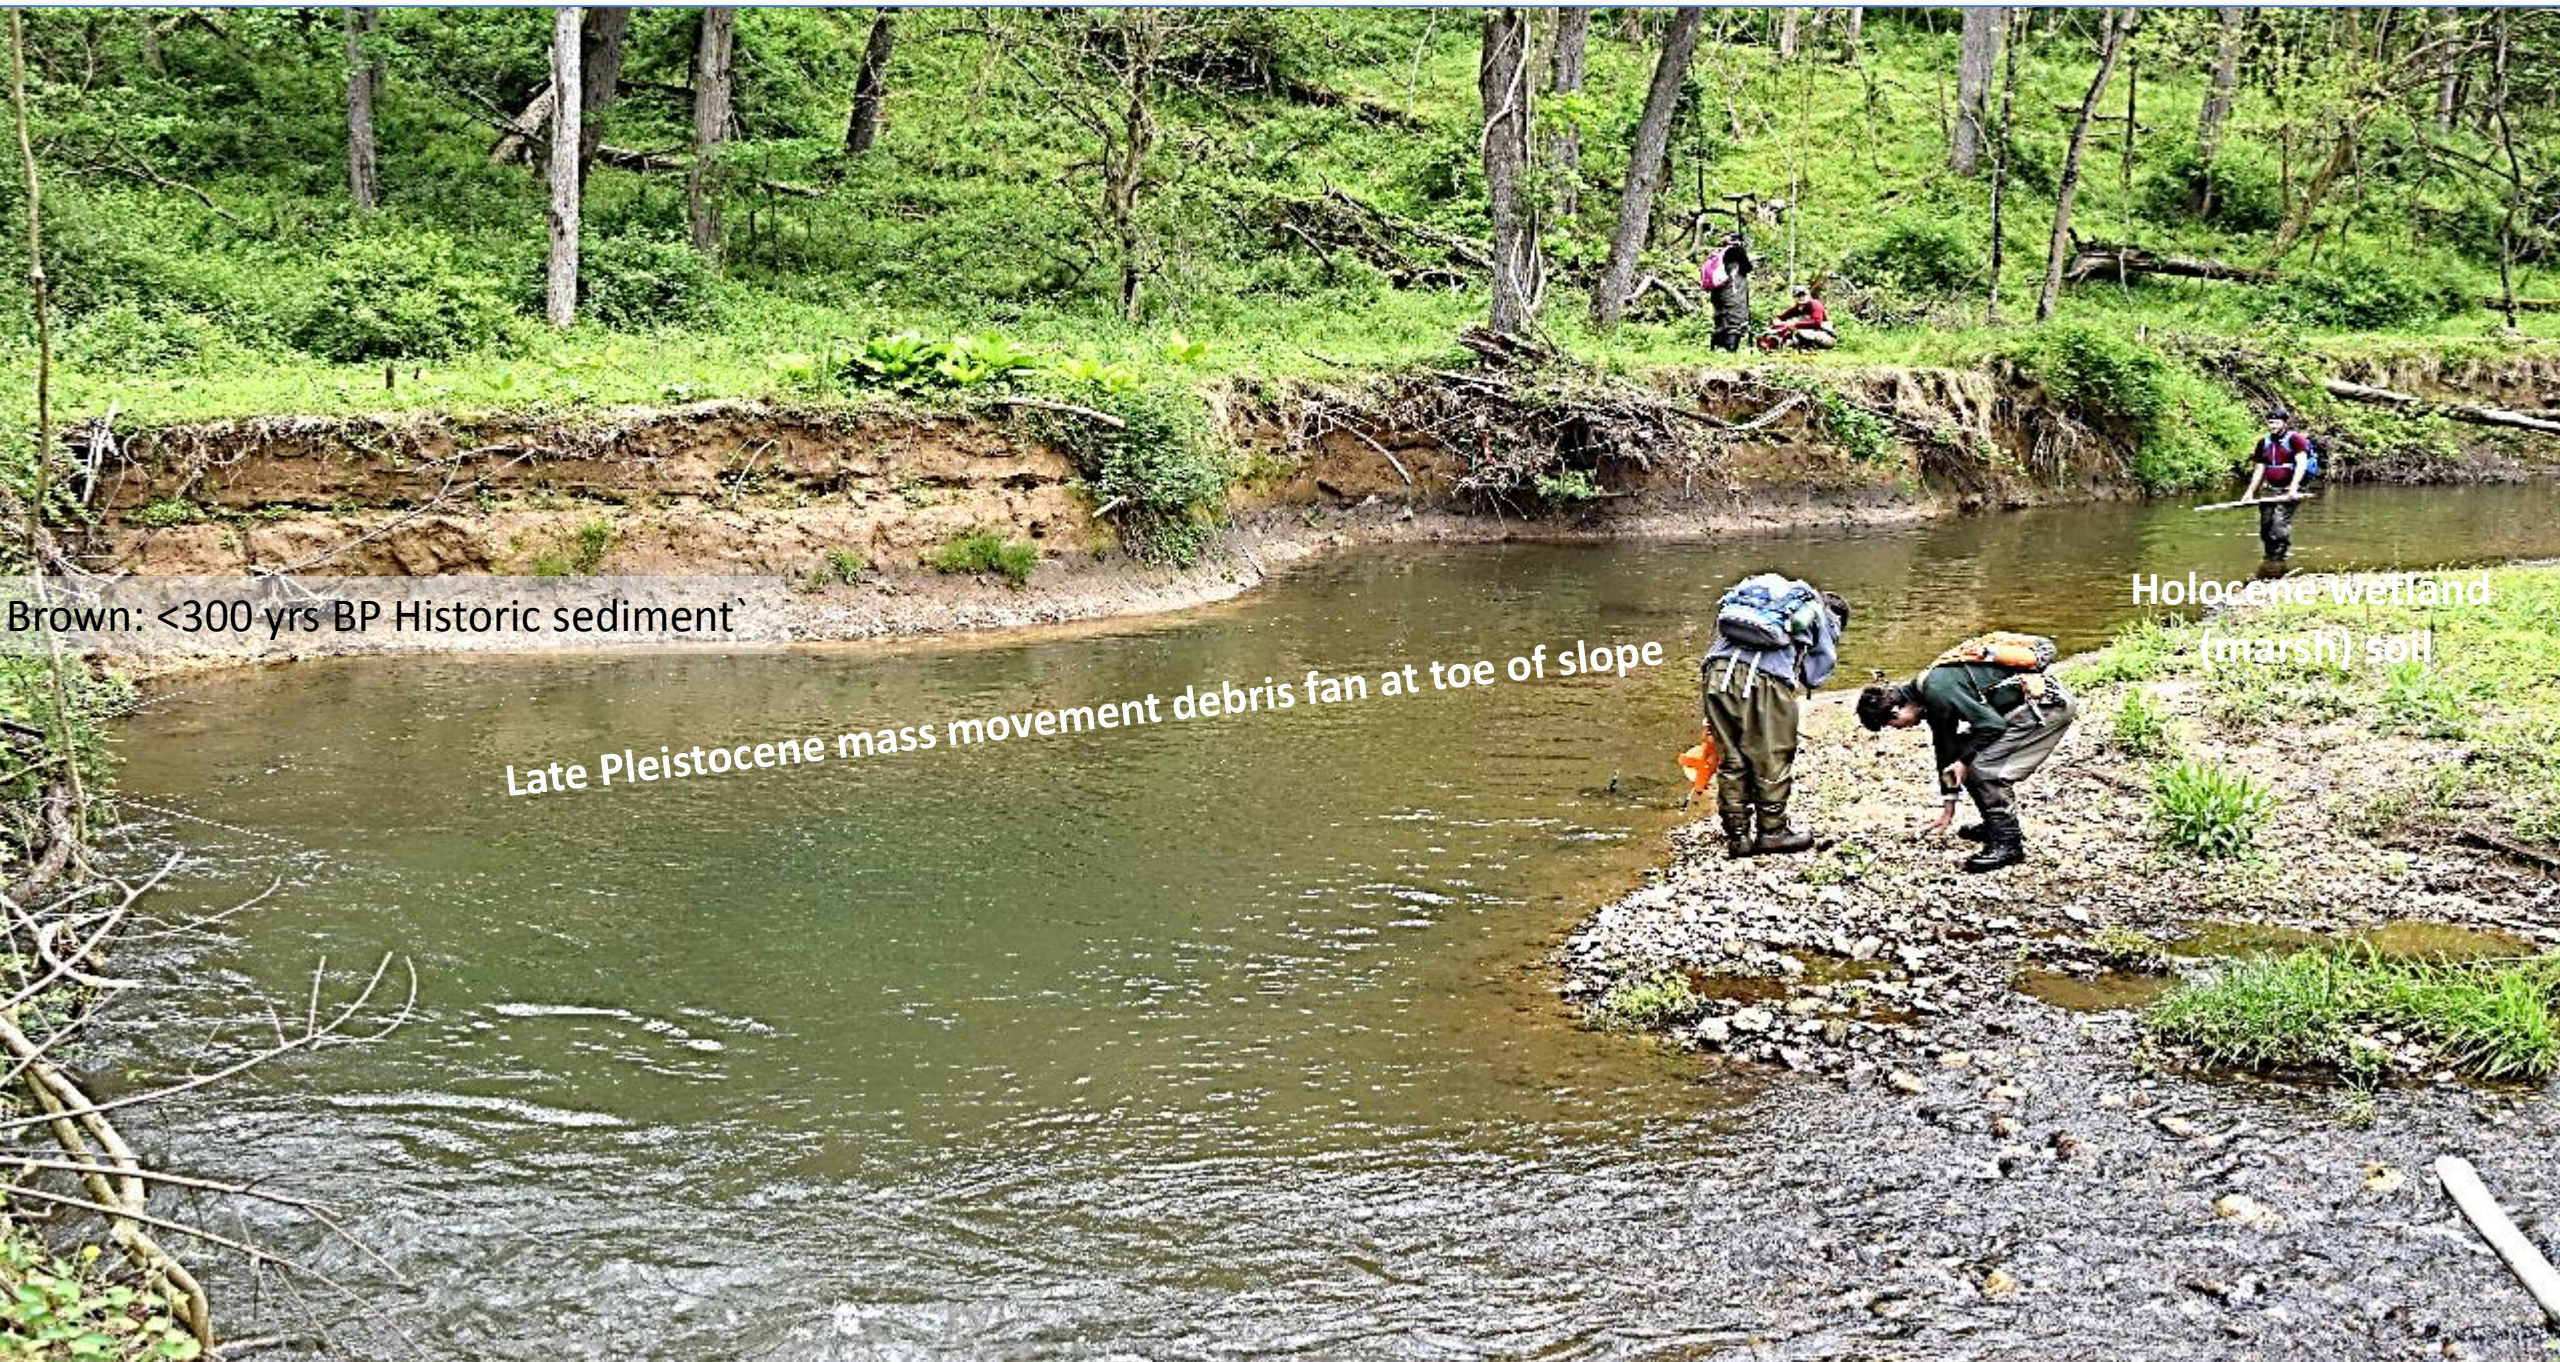
Piney Run—Buried debris fans at toe-of-slope; to right is buried black marsh soil in original topographic low area

Brown: <300 yrs BP Historic sediment`

Late Pleistocene mass movement debris fan at toe of slope

Holocene wetland (marsh) soil

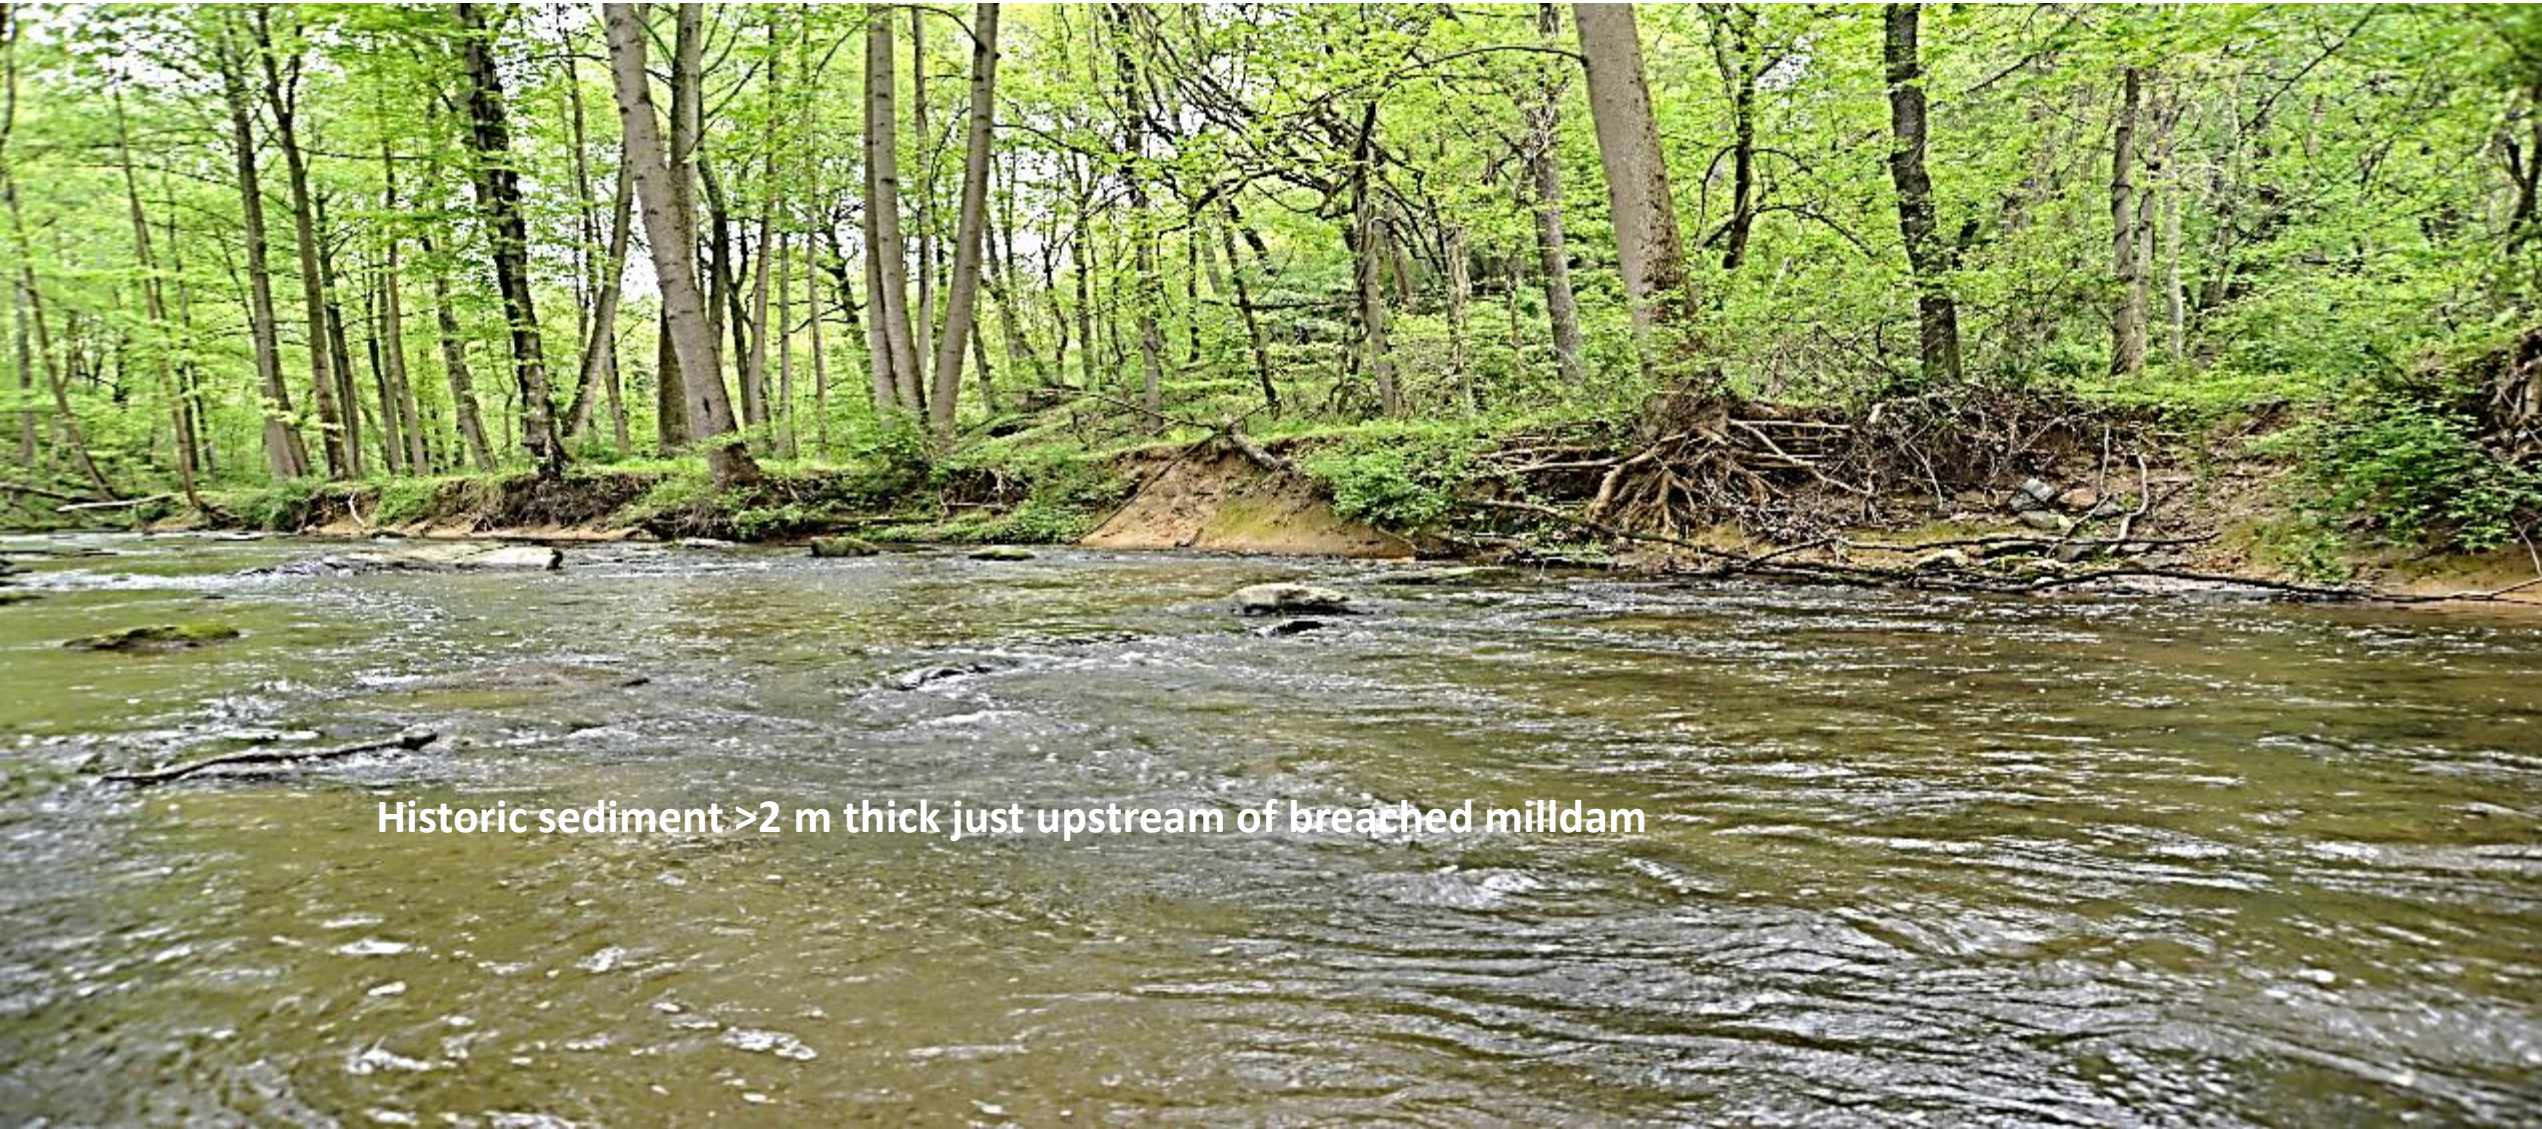
Historic sediment >2 m thick just upstream of breached milldam

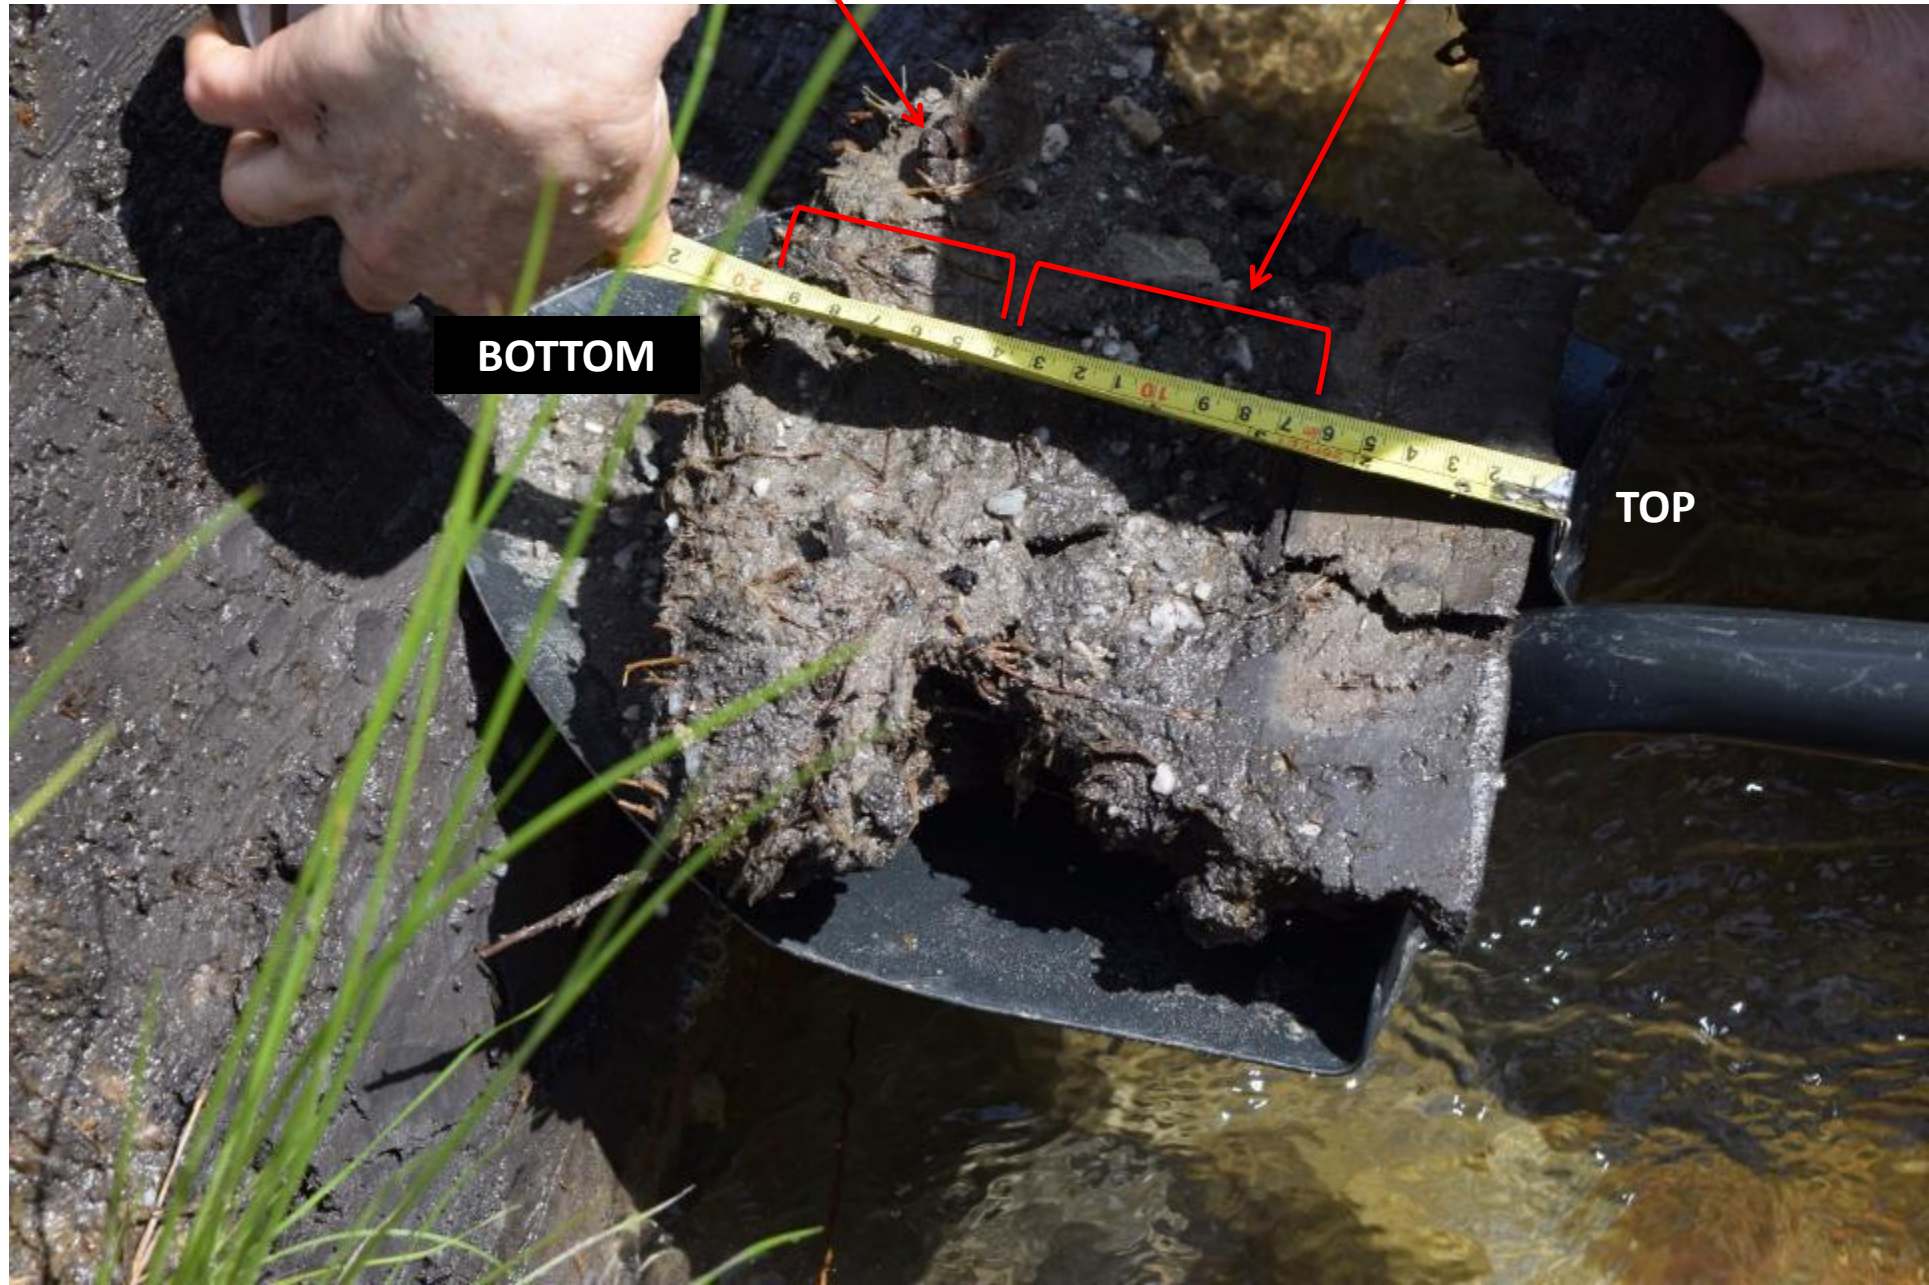
Piney Run Radiocarbon Dates
Base of Buried Hydric Soil

Nut (11,060-11,035 Cal BP)

Hemlock cone (11,070-10,710 Cal BP)

Hemlock cone (11,065-10,695 Cal BP)

BOTTOM

TOP
