# HURRICANE ISABEL AND EROSION OF CHESAPEAKE BAY SHORELINES, MARYLAND

E.L. Hennessee and J.P. Halka

Coastal and Estuarine Geology Program, Maryland Geological Survey, Baltimore, MD, USA 21218

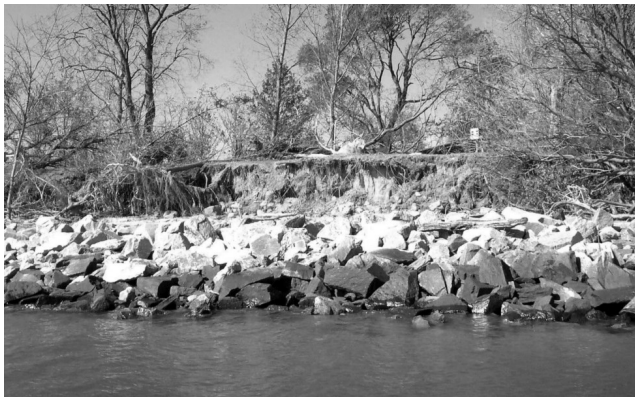
Along shorelines eroded by the action of wind-generated waves, the storm surge's main effect was to expand the zone of wave influence both vertically and laterally (Figures 2a and 2b). Along high banks and bluffs, the surge elevated wind waves, extending the line of wave attack progressively higher up, and then down, the bluff face. At the bluff's base, both manmade and natural protection (e.g., a narrow beach at the bluff base) were overtopped. Laterally, the waves reached much further inland than normal. Upland areas not usually subject to wave attack were eroded during Isabel. Flooding also increased fetch.

**Figure 2.** Processes of erosion. Bank erosion due to: a) vertical and b) lateral expansion of zone of wave influence; c) bulkhead failure and fastland scour associated with storm surge ebb; and d) undermining of mature trees. (Photos courtesy of Scott Alexander, St. Mary's County Dept. of Public Works (a); Jim Stein, Anne Arundel Soil Conservation District (b & d); Candy Crowell, Baltimore County DEPRM (c))

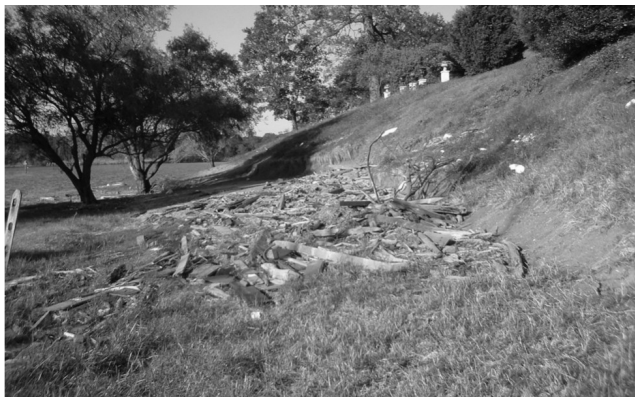
flow. Along protected reaches, the ebb produced selective failure of erosion control structures that had been overtopped by the flood (Figure 2c).

Although many erosion control structures remained intact after the storm, most were overtopped by the surge. Bulkheads and similar structures constructed higher than the land surface failed selectively from behind as the surge ebbed. Once a structure was breached, water channeled through the opening, commonly scouring a semi-conic section—wider at the top and narrower at the base—from the exposed bank. During the storm surge flood, structures backed by higher banks or bluffs directed the wave attack higher up the bluff face; sediments were gouged from there, rather than from the toe of the slope.

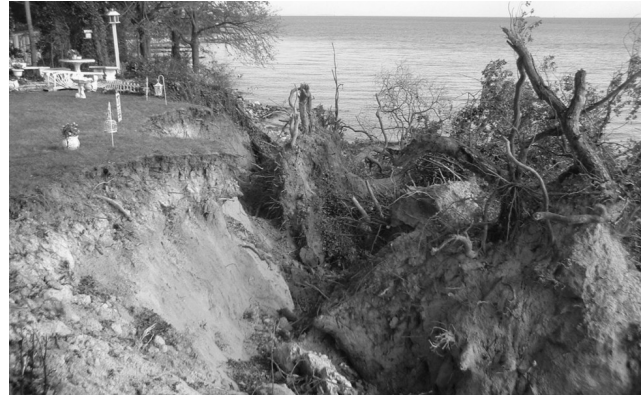
Some of the most dramatic examples of storm-induced erosion involved the uprooting of trees (Figure 2d). Generally, the extensive root systems of large trees stabilize the upper part of a slope, until the root mat is undermined. When a tree falls, it can pull away as much as 5–10 m<sup>3</sup> of bank material [13]. During the storm, other factors may have contributed to the collapse of trees along the shoreline: the high soil moisture due to above average precipitation in 2003; the sail effect produced by trees in full canopy acting like sails to catch the tropical-storm-force winds; and, on the shoreward side, the absence of shielding that would have been afforded by neighboring trees. For a while, the downed trees and the mounds of eroded sediment will shield newly exposed banks from wave erosion. Once the eroded sediment washes away and the trees disintegrate or float away, though, direct wave attack will resume. Longer term, the effects of brackish water flooding and
