Lake Champlain Phosphorus TMDL

Kari Dolan, Ecosystem Restoration Program Manager
October 10, 2014

VERMONT LAKE CHAMPLAIN
PHOSPHORUS TMDL PHASE 1
IMPLEMENTATION PLAN

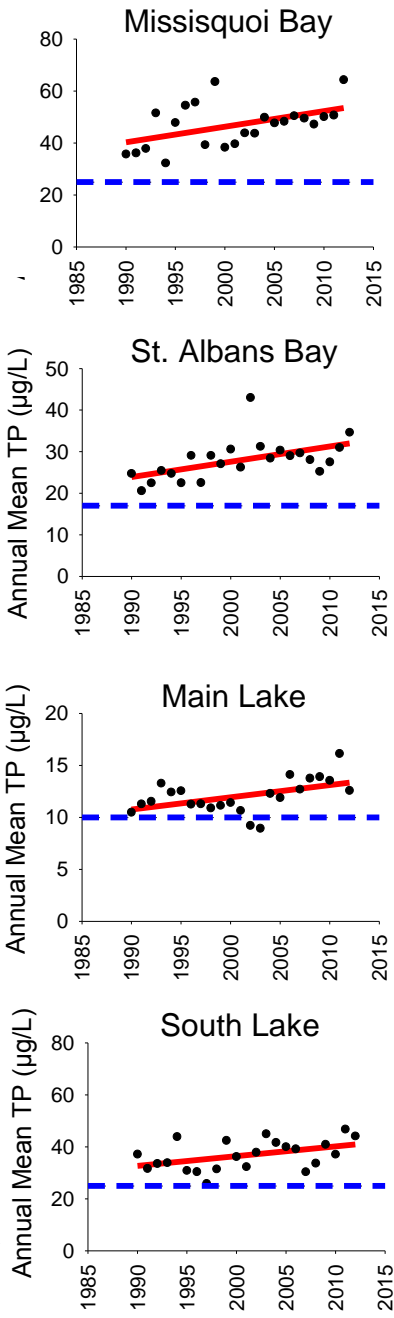
Trends in Lake Champlain Phosphorus Concentrations

— Trend line
- - - Water quality standard

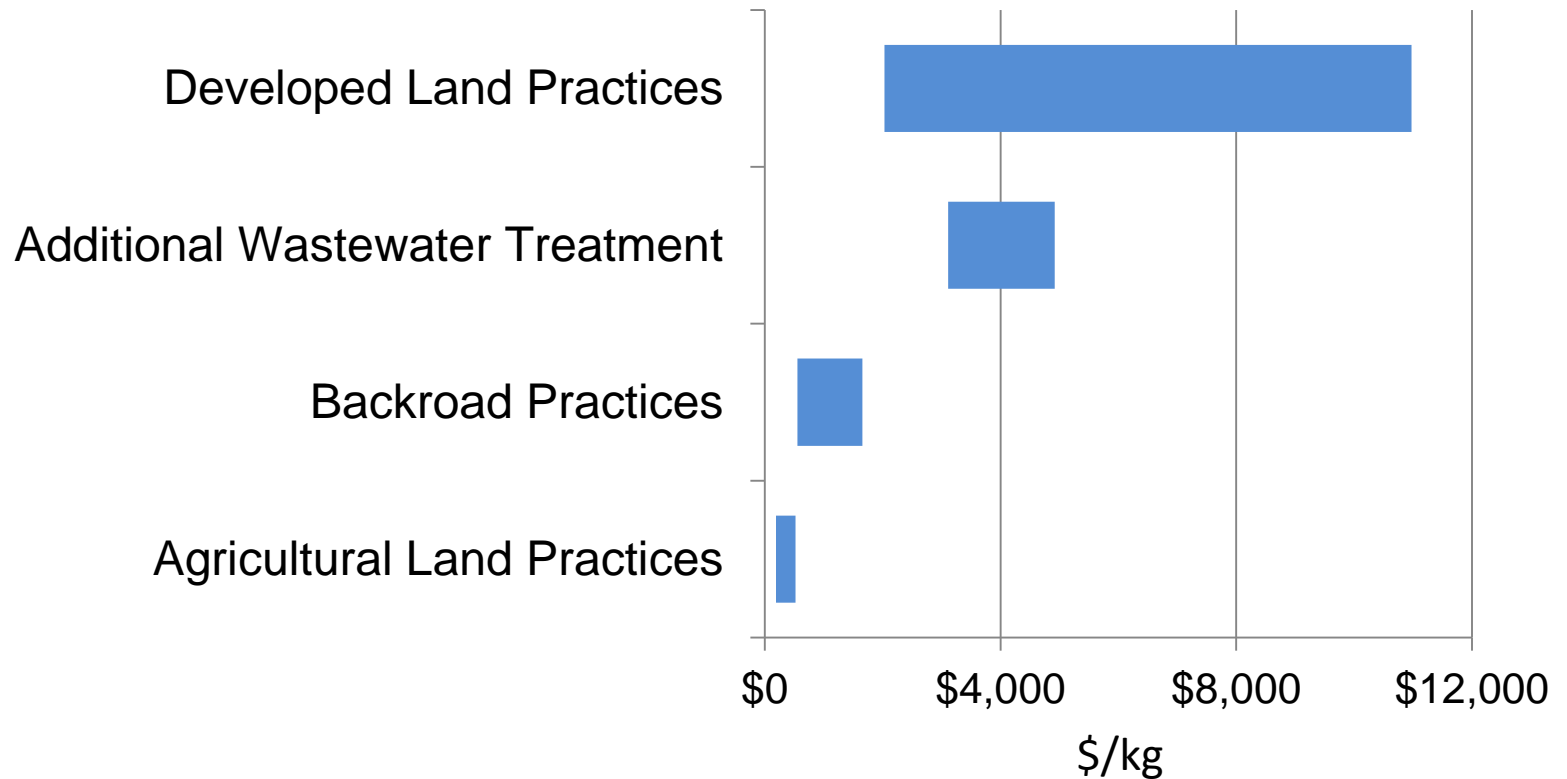
Relative Cost-Effectiveness of Actions by Source

Range of Annualized Cost (per kilogram of Phosphorus Reduced)

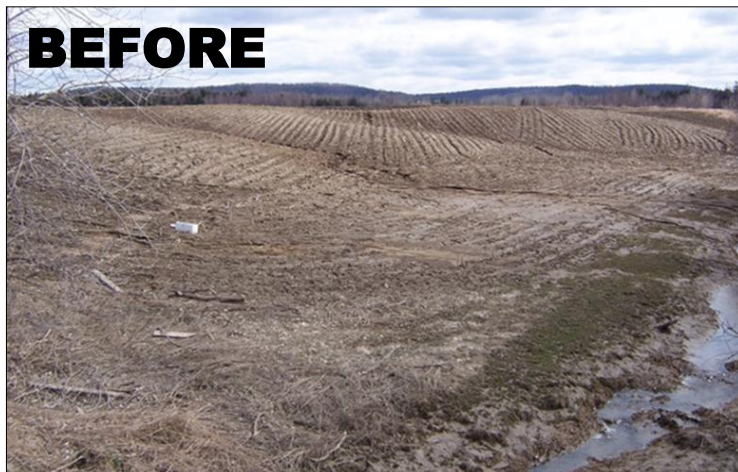
Corn crop showing bare soil & no buffer, increasing erosion and phosphorus loading

Proposed Rule Update: State Accepted Agricultural Practices (AAPs) and Technical Assistance Example: Increase buffer size and crop rotation

- Achieves 40%-80% reduction in Total Phosphorus
- Estimated project cost = \$6,000 (100 acres treated)

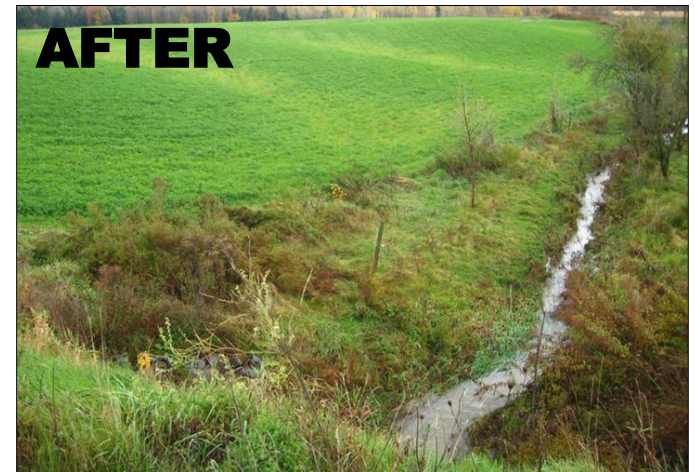
Hay crop & buffer reduce erosion and phosphorus delivery to streams

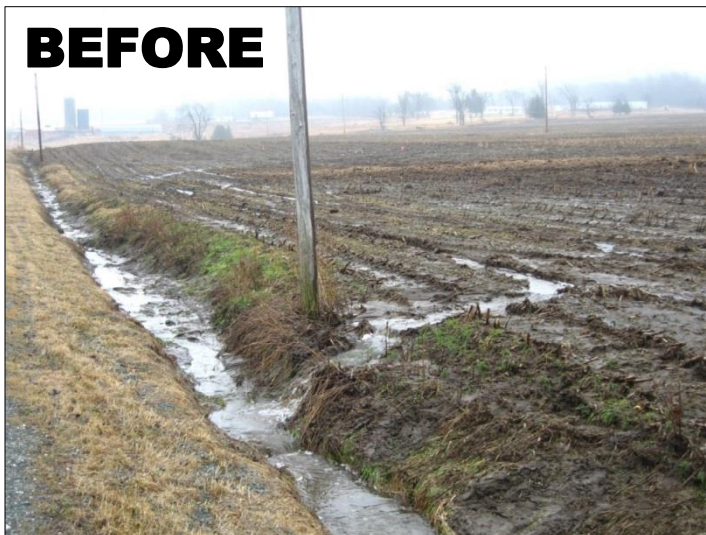
Runoff draining into ditch

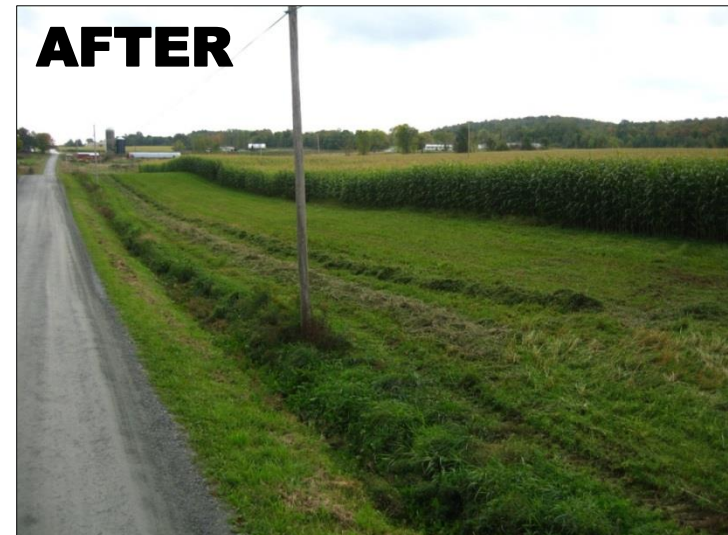
Vegetated buffer along ditch

Proposed Rule Update: State Accepted Agricultural Practices Example: Vegetated buffer on Field and Roadside Ditches

- Achieves 40%-80% reduction in Total Phosphorus
- Estimated project cost = \$1,350 (3 acres treated)

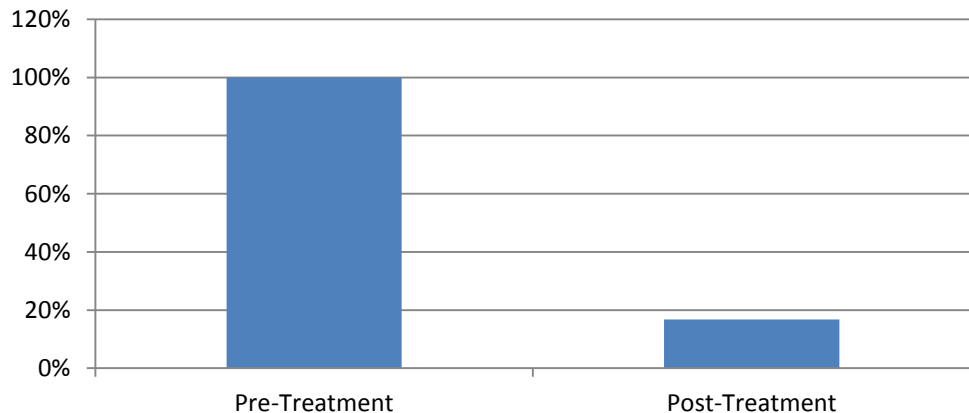
Effectiveness of Stormwater Treatment
(Phosphorus load as a percent of pre-treatment level)

- Stormwater treatment achieved over 80% reduction in Phosphorus
- Estimated cost for stormwater treatment for land already developed = \$30,000 per acre of impervious surface

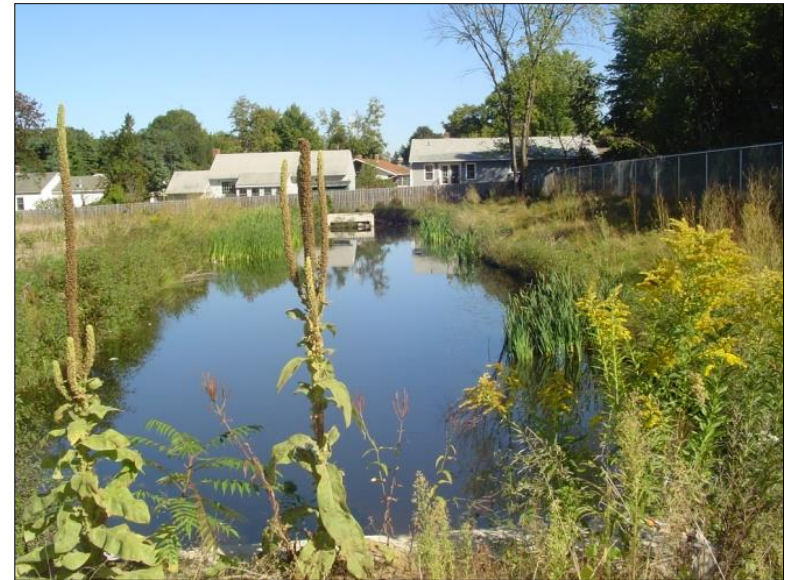
Expanded stormwater treatment pond

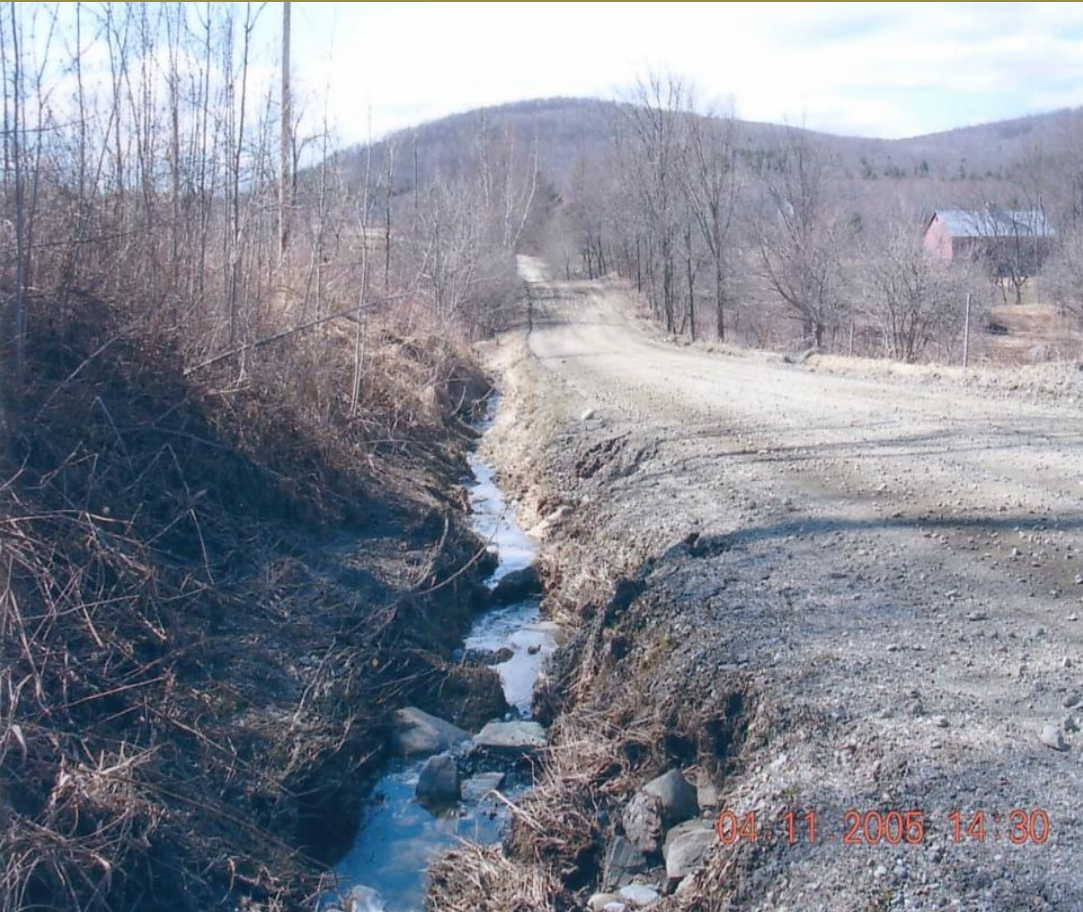
Eroding roadside ditch

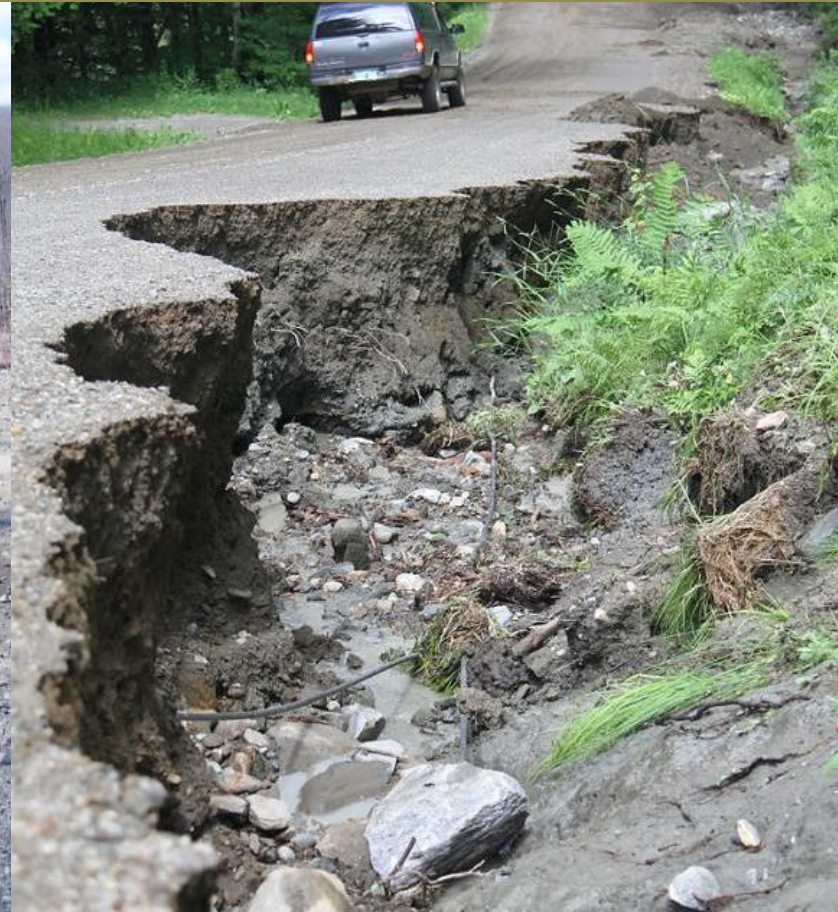
Storm-damaged gravel road

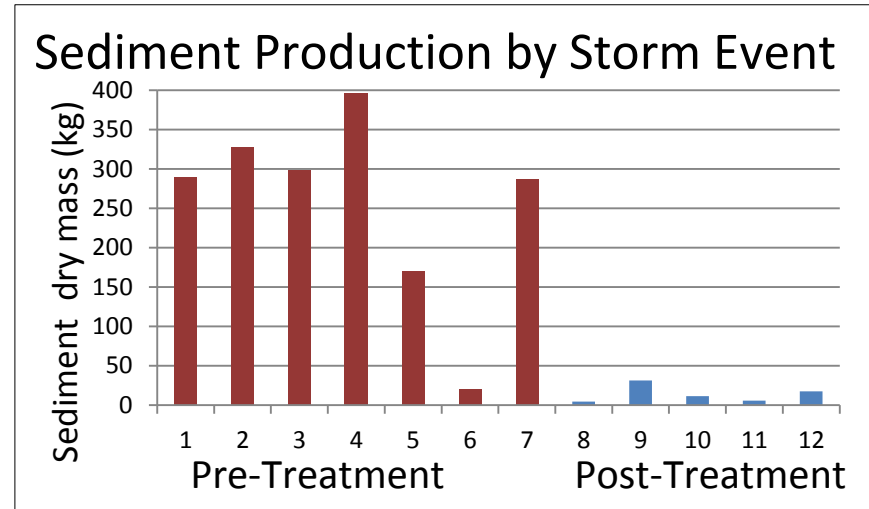
Wempe, 2013

- UVM Controlled Study found a dramatic reduction in polluted runoff from Best Practices such as rock-lining ditches on steep roads
- Estimated project cost = \$3,000 (1,000 linear feet treated)

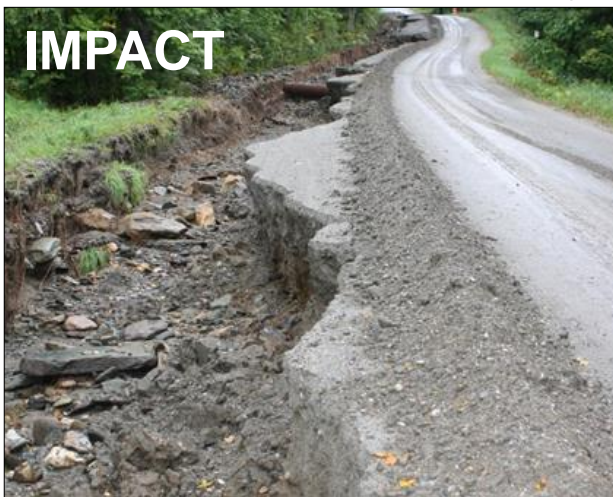
Eroding roadside ditch

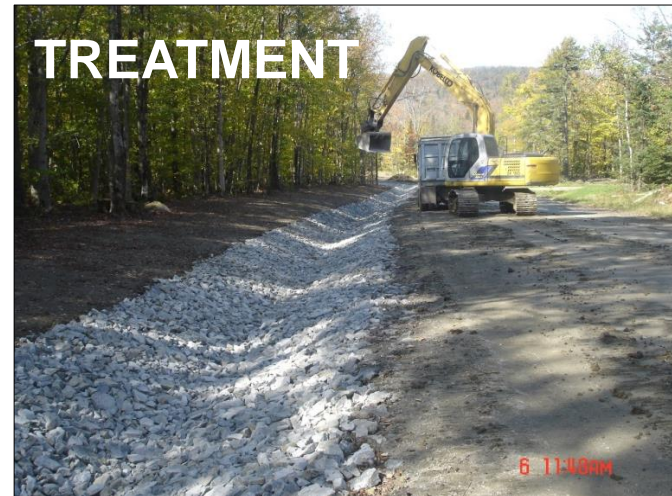
Ditch stabilization saves road and reduces erosion 27

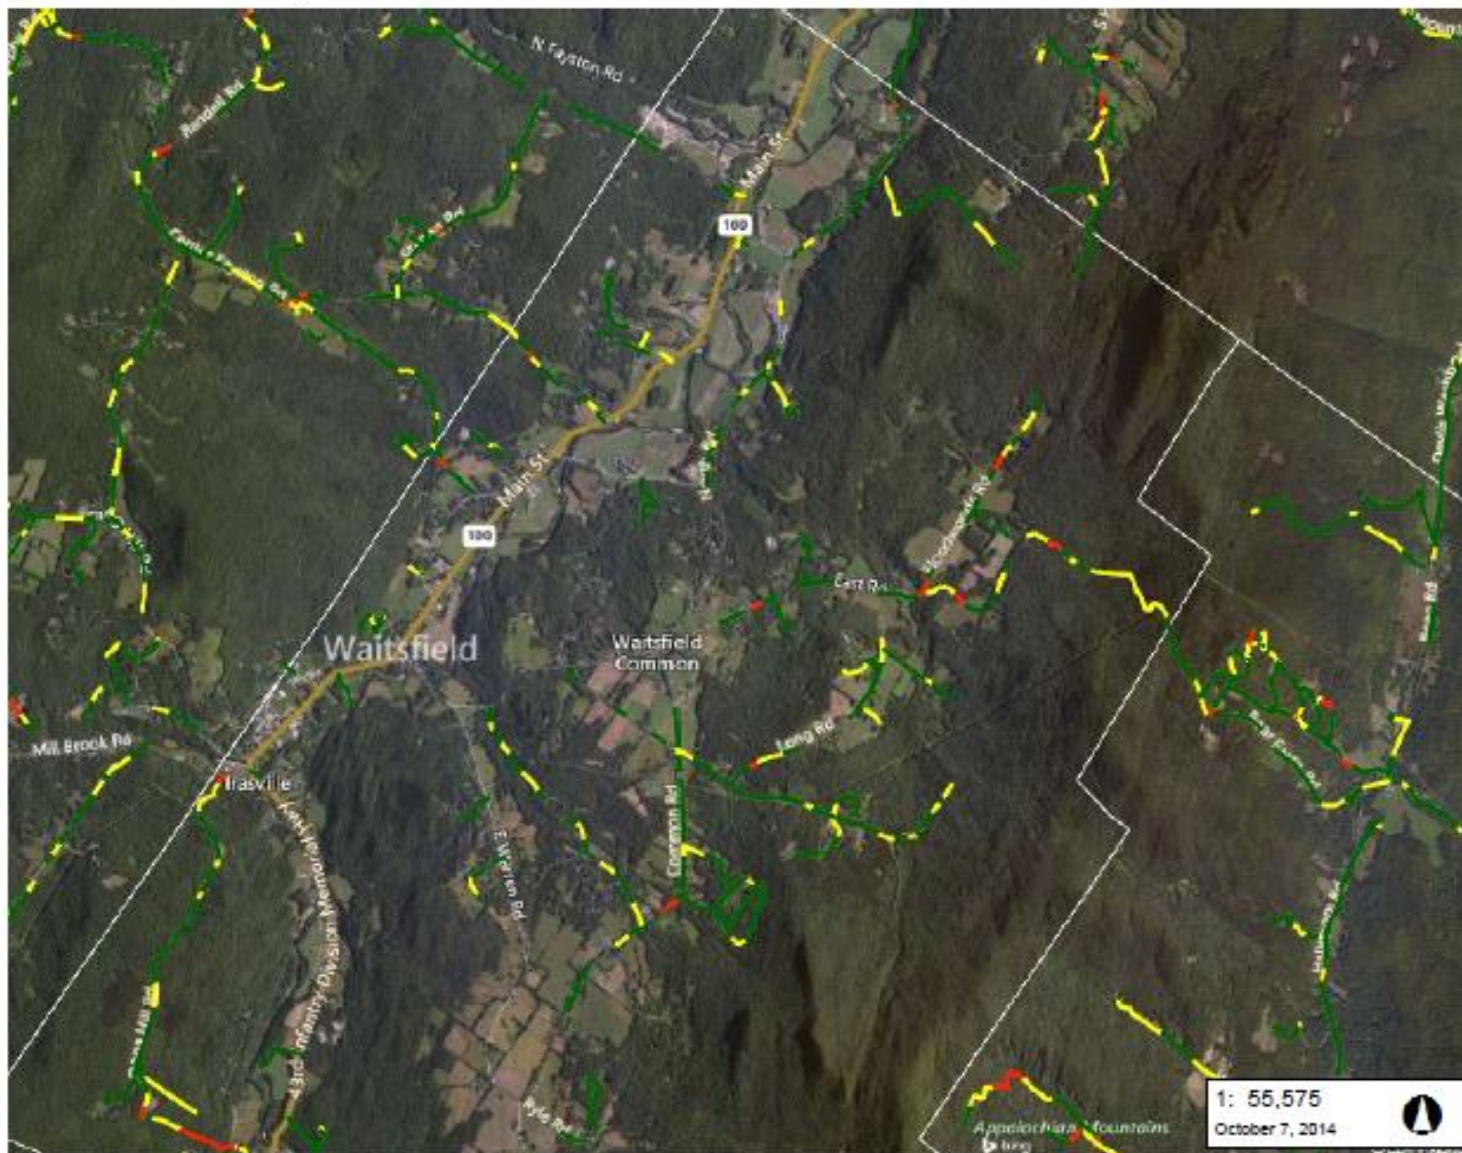
- Low Risk, 0.5 - 4
- Moderate Risk, 4.5 - 6
- High Risk, >= 6.5

Map depicting low, moderate and high risk for gravel road erosion

- Gravel Roads and driveways
- Erodible soils
- Frequently flooded soils
- Rivers and streams
- Wetlands
- Lakes and Ponds
- Digital Elevation Model to calculate road gradient
- Slope
- “Problem” culverts
