# Understanding the effects of roads in upland settings on hydrology, geomorphology and water quality

**Beverley Wemple**

Department of Geography and  
Rubenstein School of Environment & Natural Resources  
The University of Vermont

Replumbing the Chesapeake Bay Watershed Workshop  
Easton, MD  
October 9-10, 2014

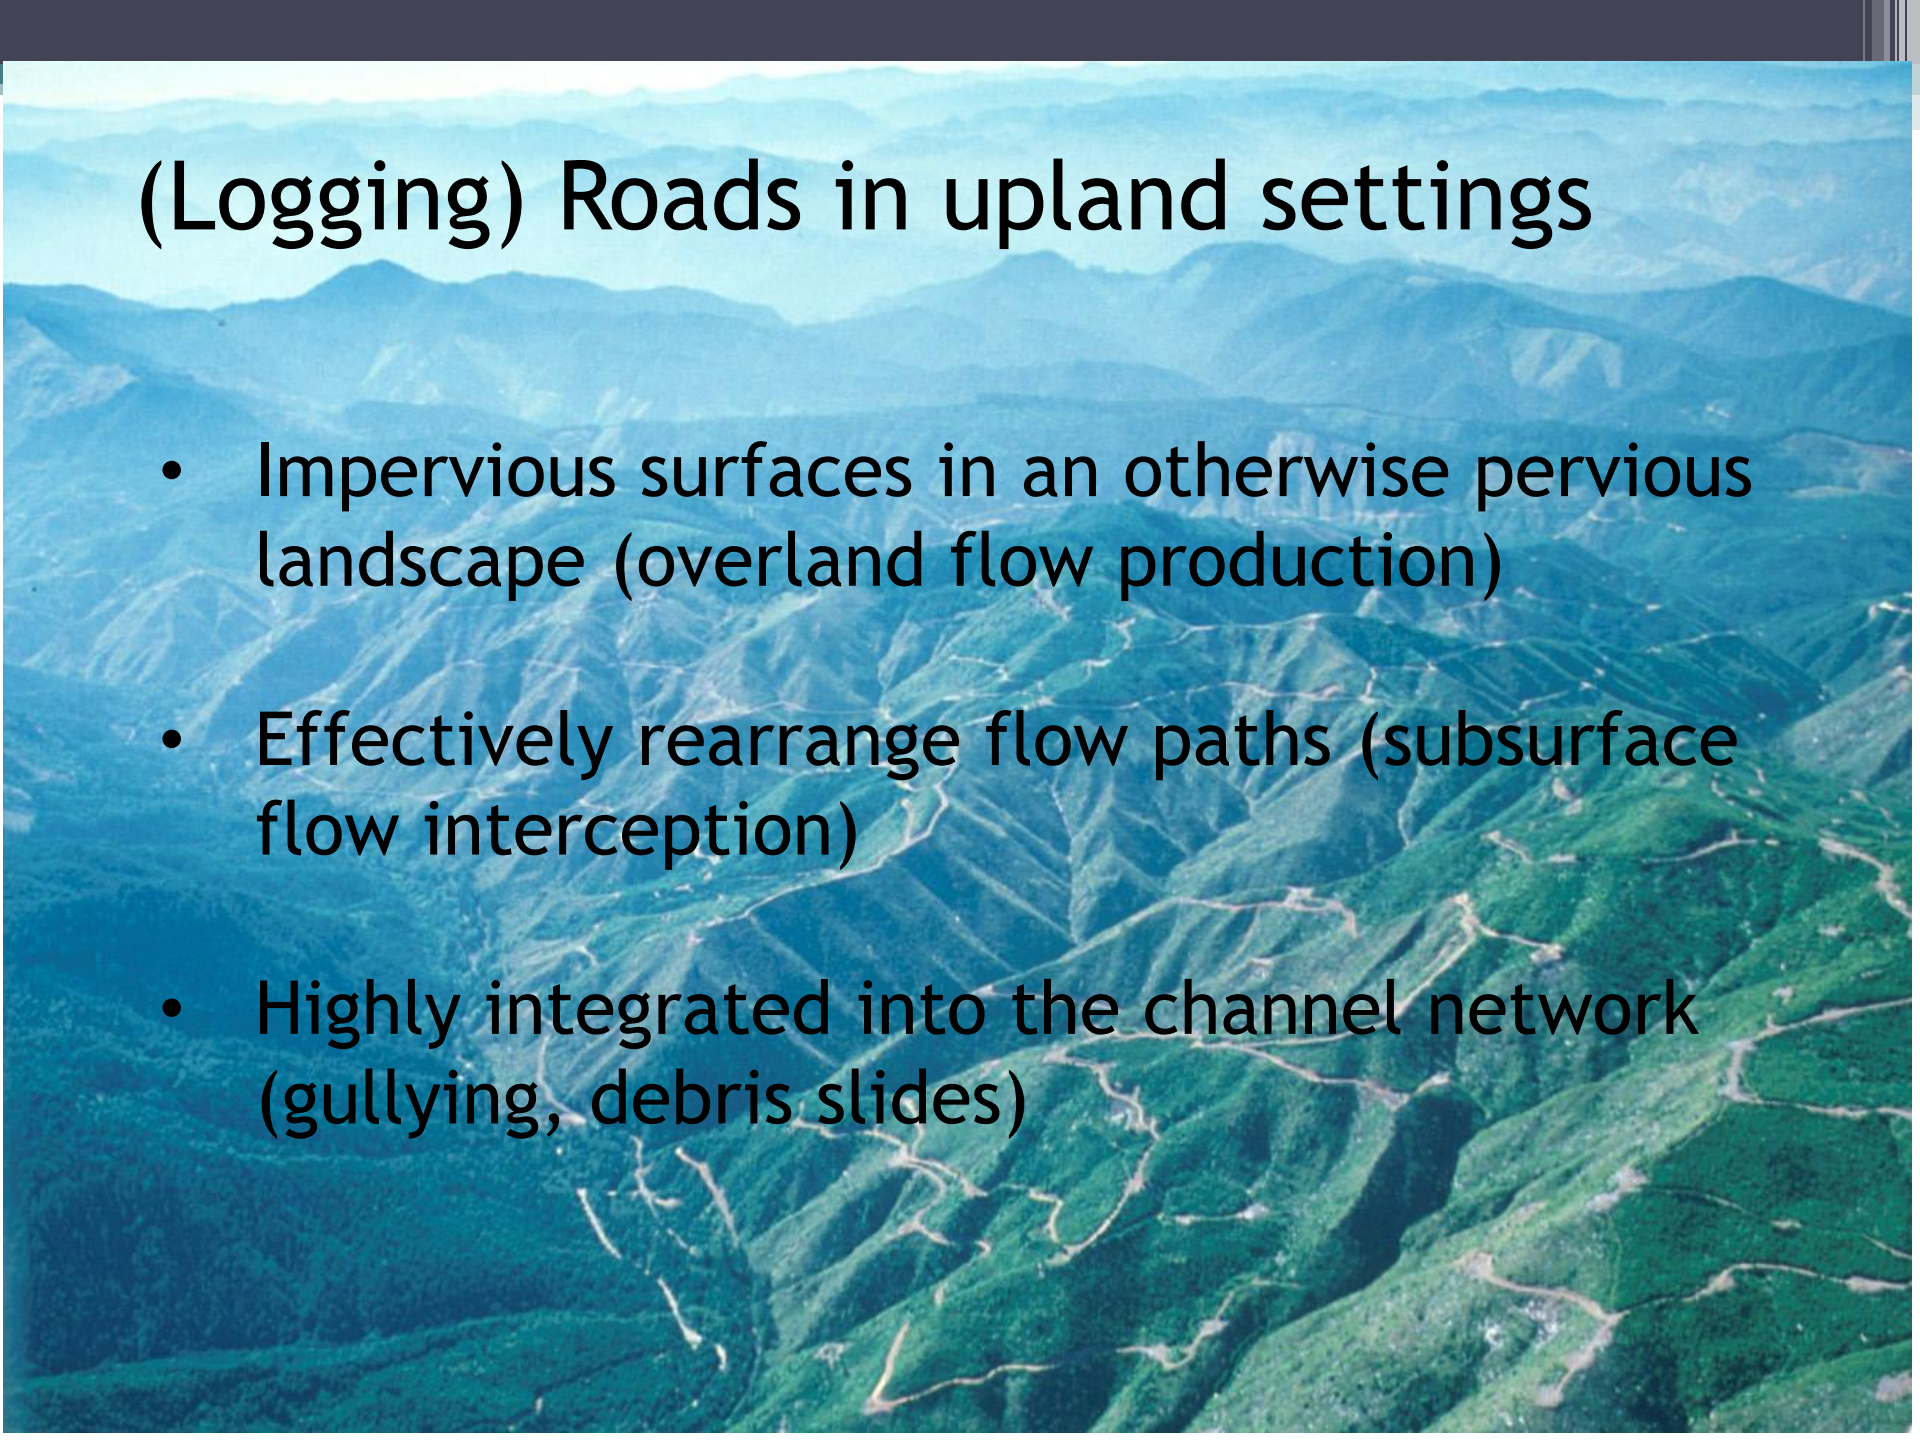
# (Logging) Roads in upland settings

- Impervious surfaces in an otherwise pervious landscape (overland flow production)
- Effectively rearrange flow paths (subsurface flow interception)
- Highly integrated into the channel network (gullying, debris slides)

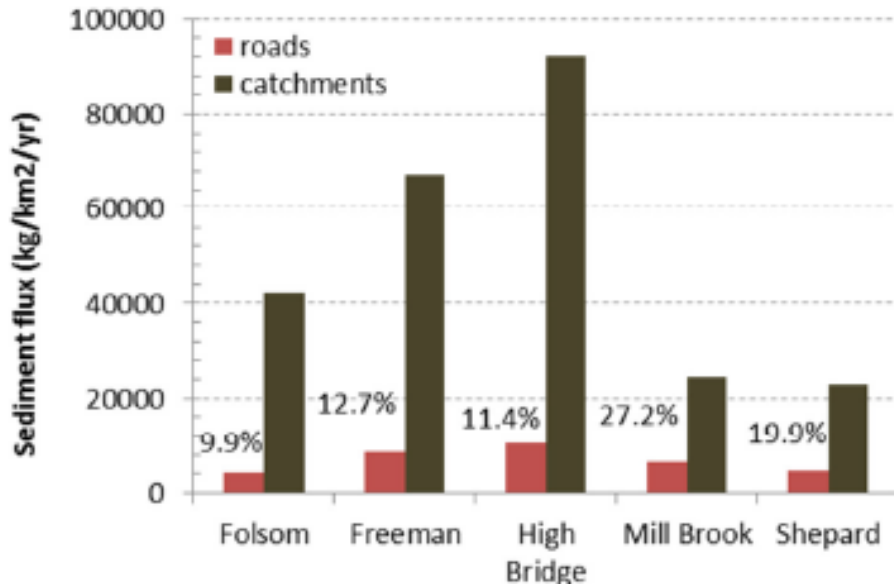
## Suspended Sediment

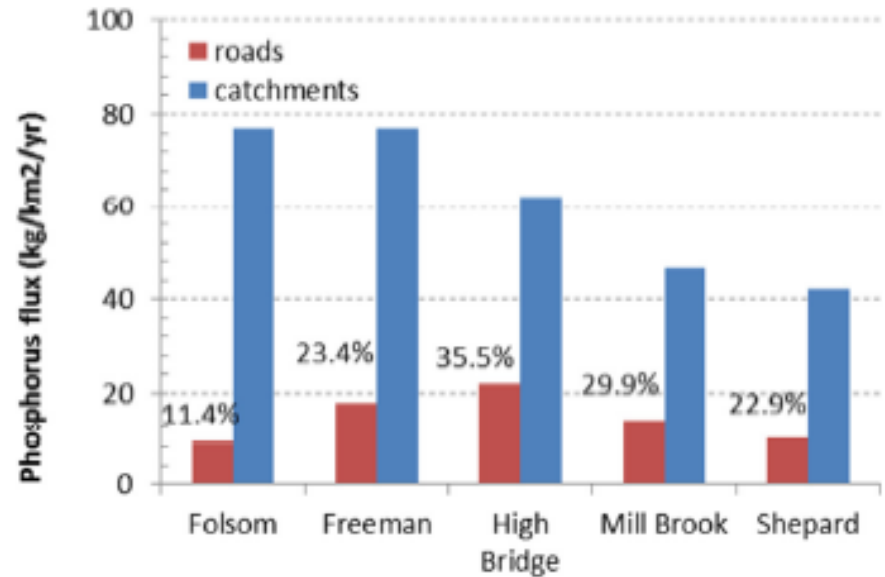
## Total Phosphorus

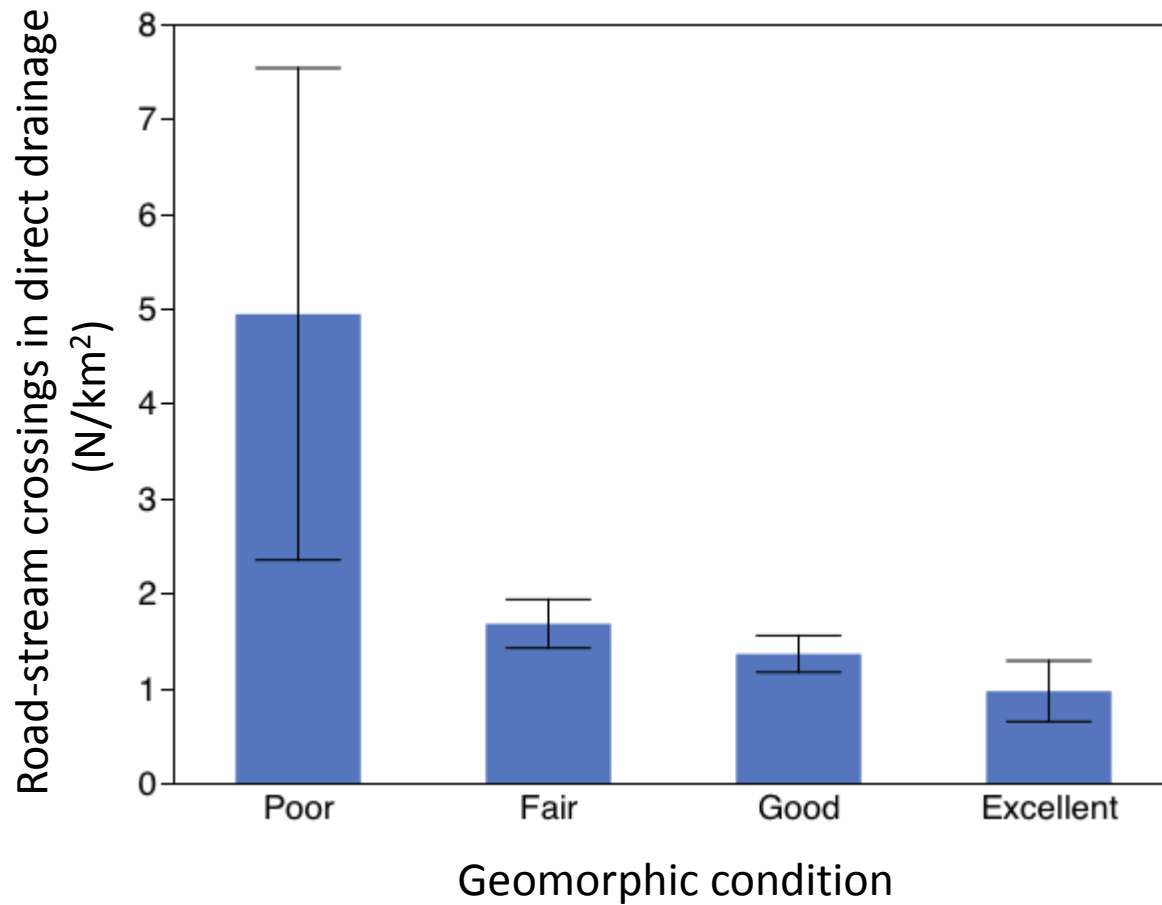
# Density metrics of channel condition

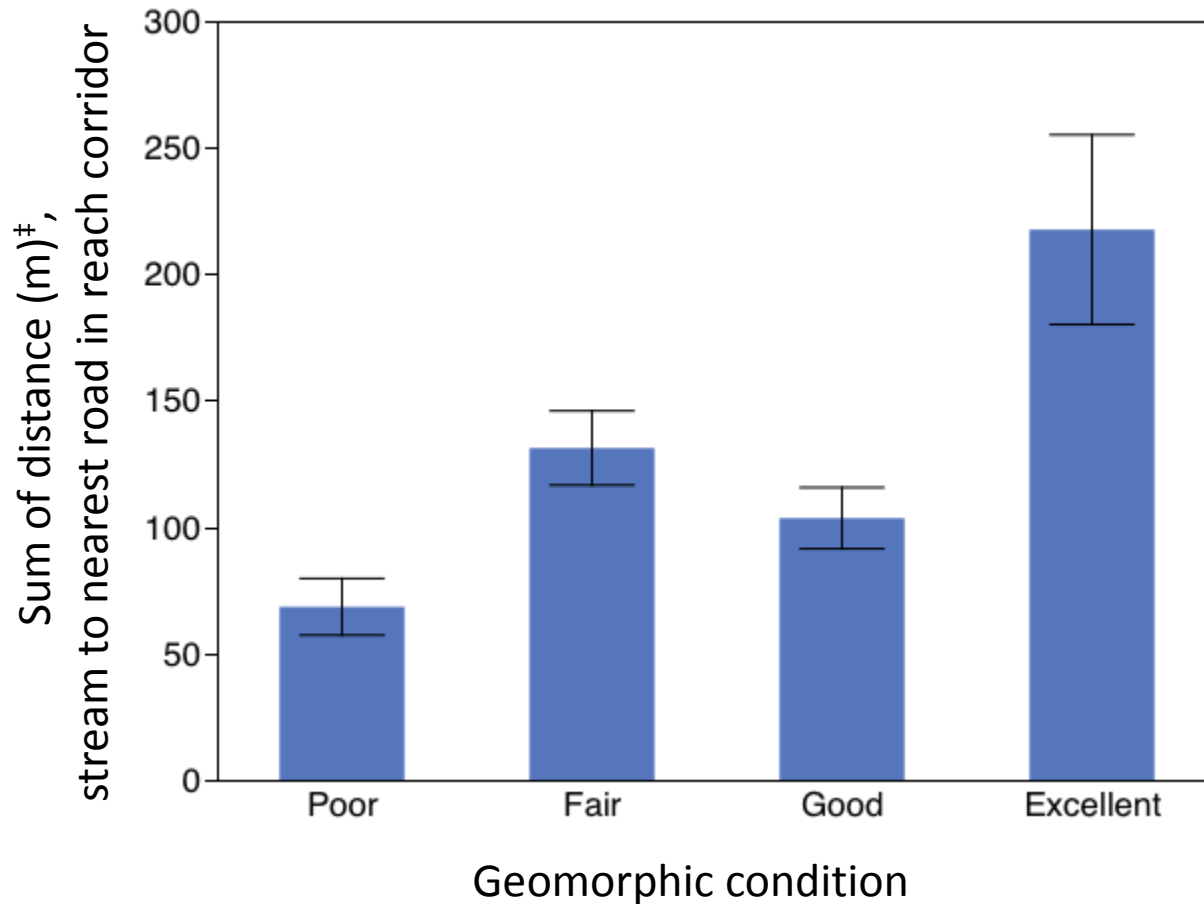
# Proximity metrics of channel condition

‡ Normalized by stream length
