# Unintended Consequences of Wetland Creation / Restoration

Michael Williams  
University of Maryland

# Magothy River - Cypress Creek

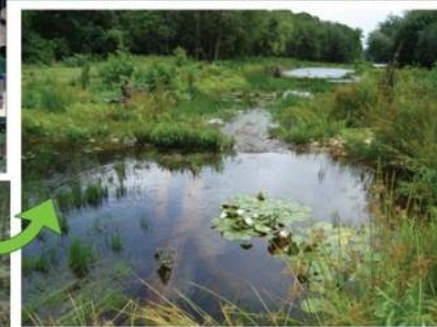
3.6 ha restoration area

HEADWATER WETLAND CONVERTS STRAIGHT STREAM/DRAINAGE CHANNEL INTO 1.1 ACRE OF POOLS, EMERGENT WETLANDS AND FORESTED WETLANDS.

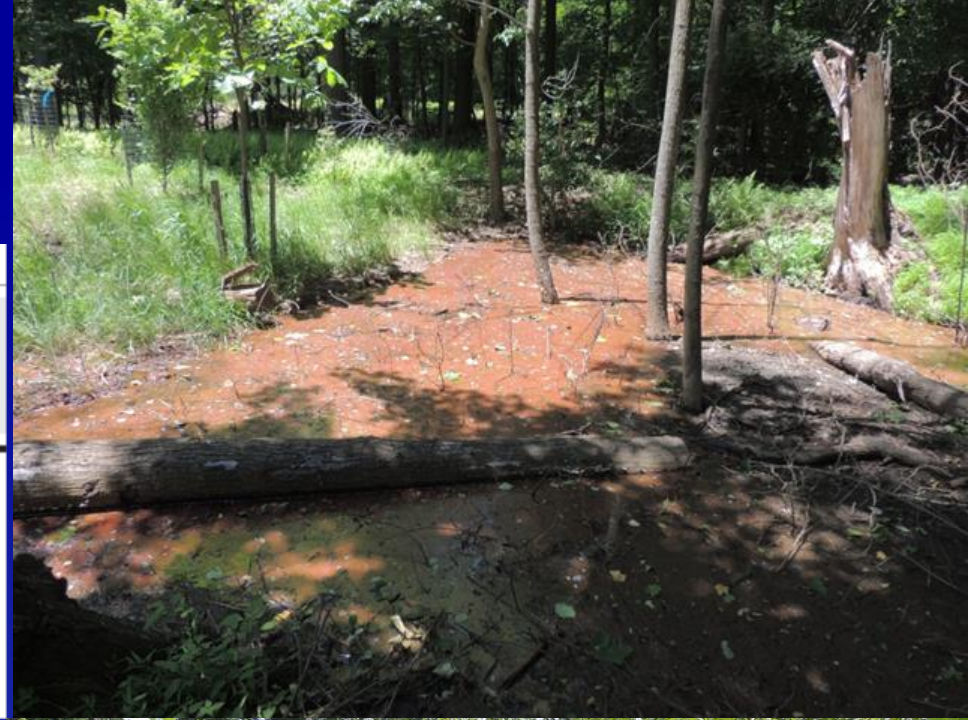
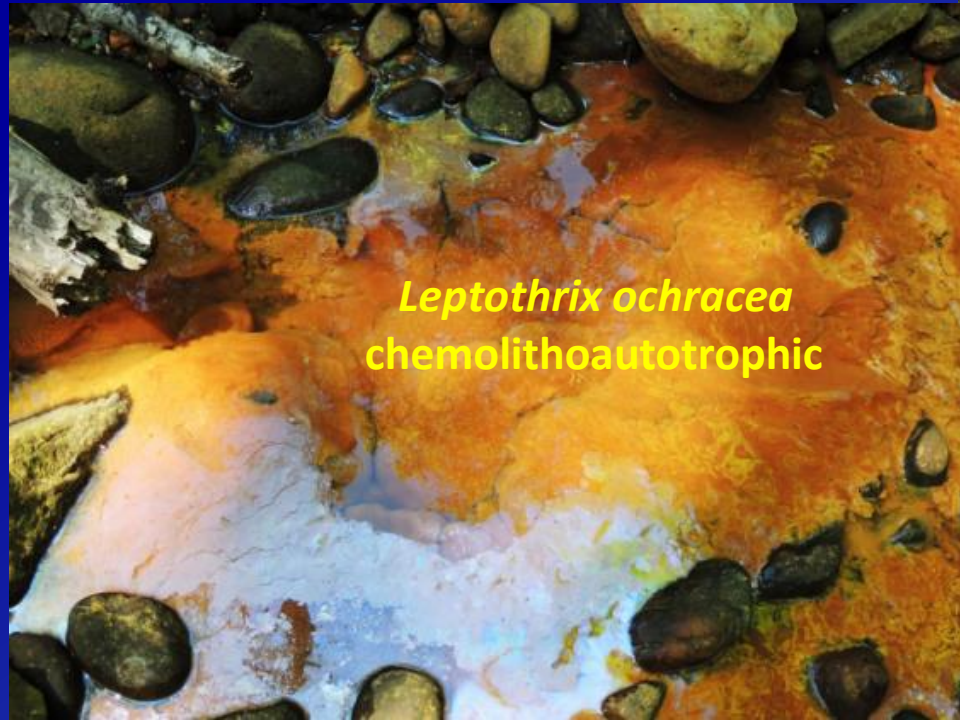
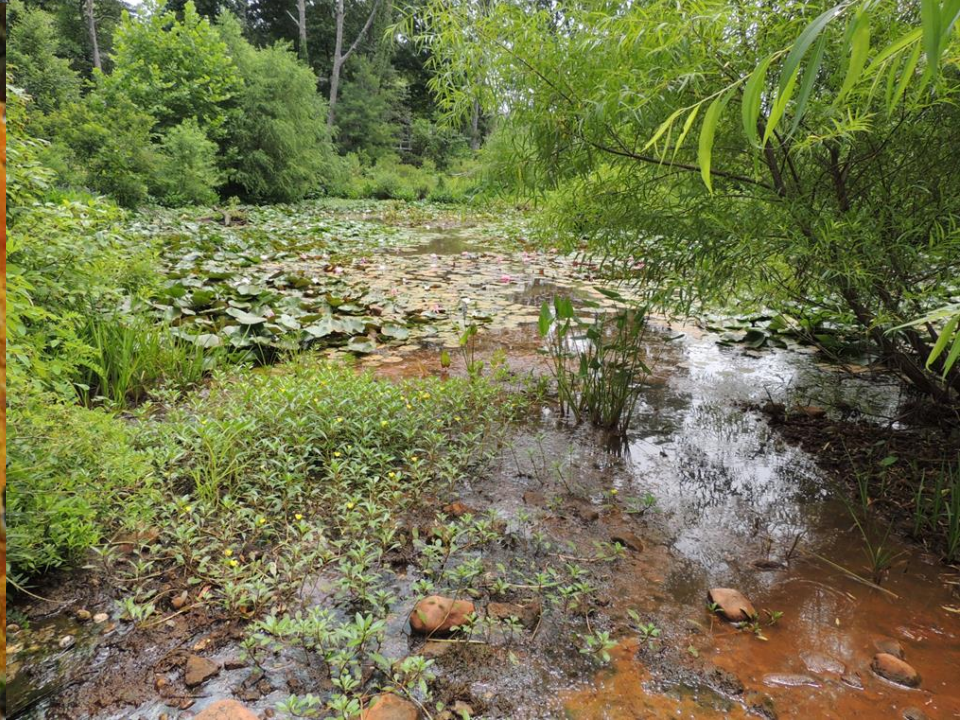
*Leptothrix ochracea*  
chemolithoautotrophic

- Unintended Consequences
  - Tree and riparian zone losses
  - Post-construction disturbances increase sediment loads and sedimentation in wetlands
  - Excessive flocculate from Fe-oxidizing bacteria
  - Dissolved oxygen concentrations often below criteria threshold during low-flow, warmer conditions
  - Increased streamwater temperatures
  - Increased light availability increases gross primary production (GPP)
  - Increased methane production

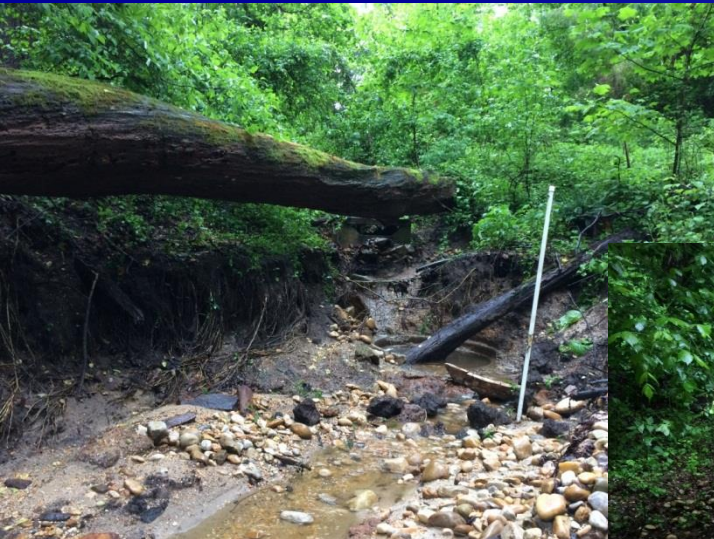
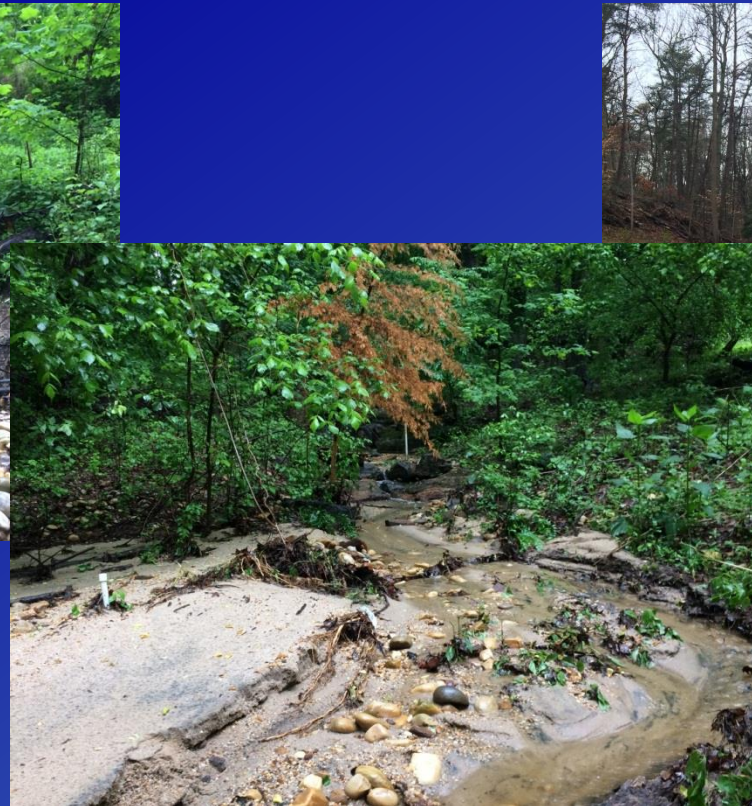
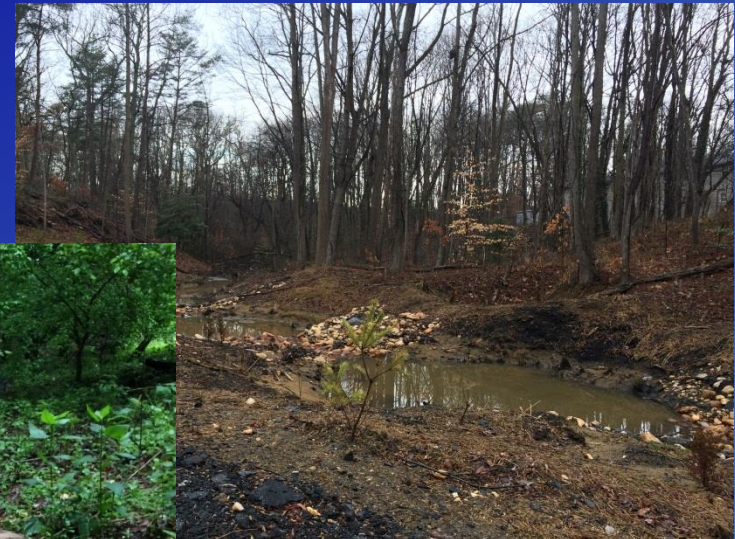
# Post-Construction Disturbances

- Intense high-volume storm events and construction activities (e.g., headwater restorations)
- Elevate sediment loads thereby compromising wetland habitat and water retention capacity
