Stream Restoration Using Wood-Not Just for the Coastal Plain!

- ~4,100-If stream restoration using
 - ~77 wood structures
- 1st and 2nd order stream channels

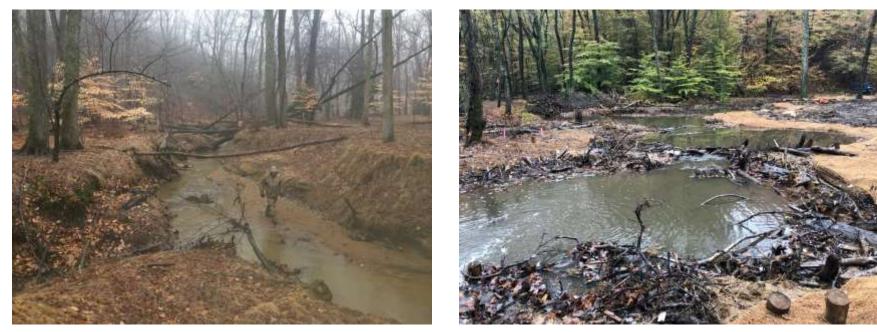
Main Tributary - Middle

February 2018

October 2019

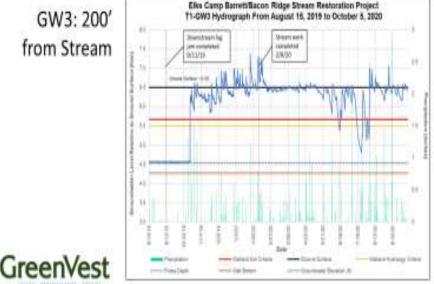
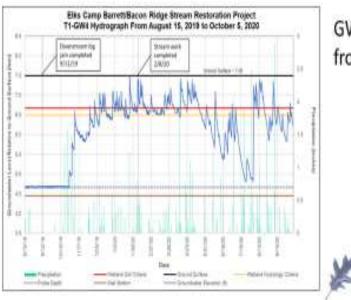
BACON RIDGE BRANCH Groundwater Monitoring: November 7, 2018 - March 6, 2019

Elks Camp Barrett Hydrographs: Transect 1

Mainstem Channel

GW1: 50' from Stream

GW2: 100' from Stream

GW3: 200' from Stream

GW4: 300' from Stream

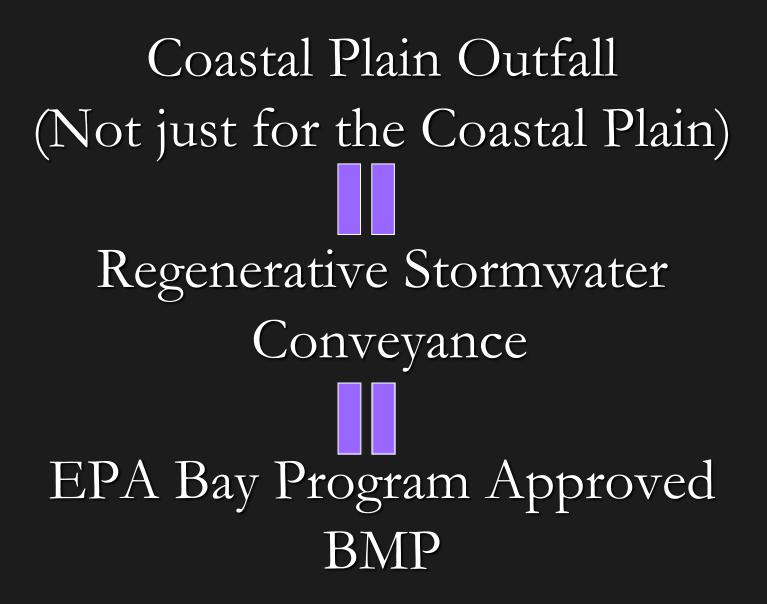
Progression of Methods for Surface Water Conveyance

Integrated Stream and Floodplain Techniques (valley restoration, baseflow channel with floodplain reconnection, etc.)

Bankfull Channel Design

Rip-rap, gabion, **Concrete channels**

Pipe

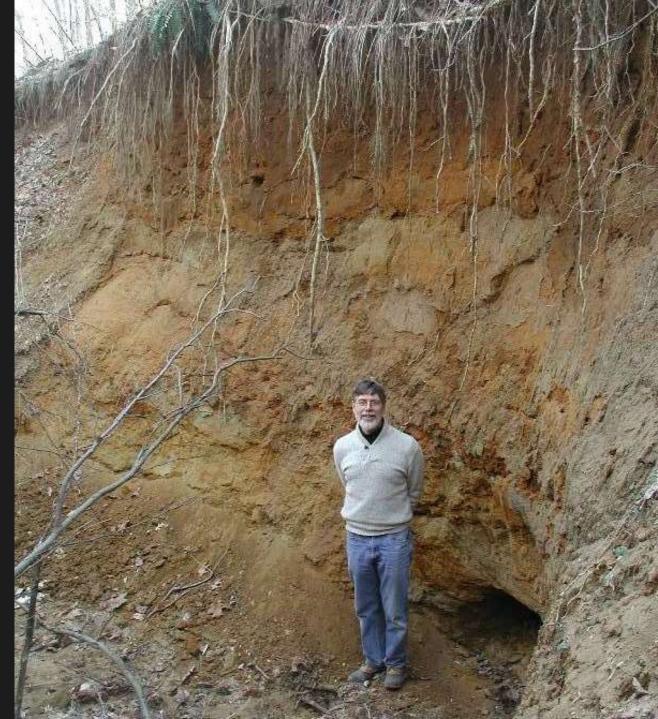
Carriage Hills Pre-restoration

22-ft incised

Adverse effect on shallow groundwater and downstream flows

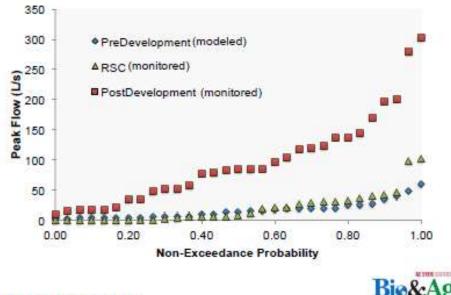
Peak Flow
