OUTCOMES FROM STREAM RESTORATION IN THE PAST

EVOLUTION IN THE STREAM RESTORATION PROTOCOLS

STAC WORKSHOP – MARCH 21, 2023

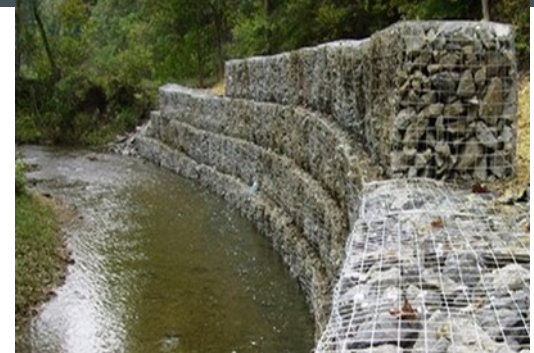
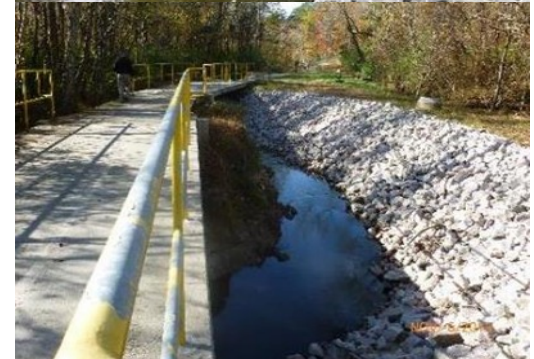
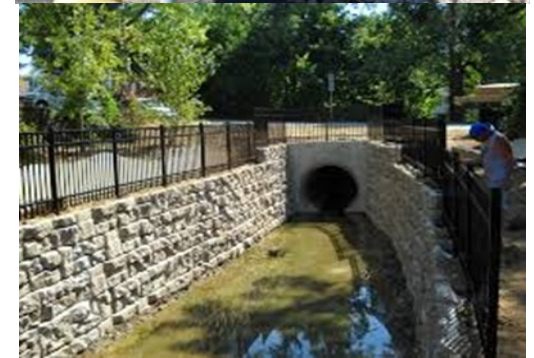
Non-Creditable

Definition: Hard, permanent structures used to protect critical infrastructure and stabilize banks. Techniques are not consistent with long-term, comprehensive restoration approaches.

- Concrete Retaining Wall
- Sheet Piling/ Planking
- Gabion
- Engineered Block Walls
- A-Jacks
- Dumped Rip Rap

- New definitions for types of bank stabilization techniques that can be used for TMDL credit.
- More emphasis on existing criteria
- Projects must demonstrate consideration of unintended consequences

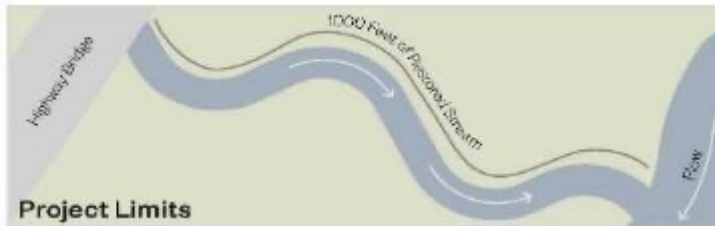
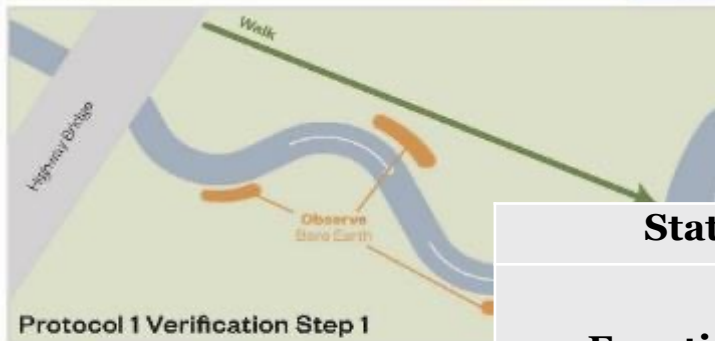
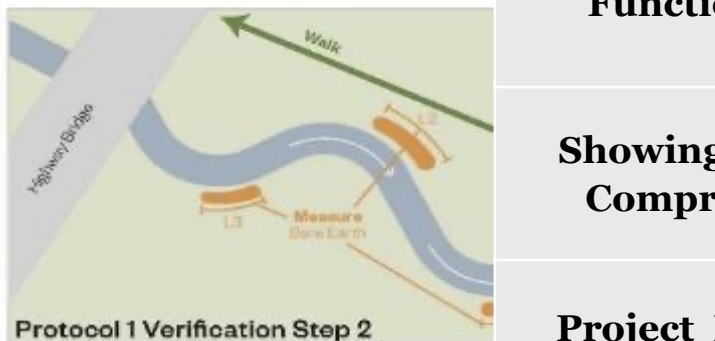
Defining Loss of Pollutant Reduction Function for Protocol 1

Criteria for Loss	Key Visual Indicators
Evidence of bank or bed instability such that the project delivers more sediment downstream than designed,	<ul style="list-style-type: none"> Severe bank undercutting (bare earth exposed) Incising bed (bed erosion evident) Flanking or downcutting structures Failure or collapse of practices

Status	% Failing *
Functioning	0 to 10% of reach
Showing Major Compromise	20 to 40% of reach
Project Failure	50% or more of reach
